Partial Discharge on Outdoor Terminations

Contamination of cable terminations causes PD

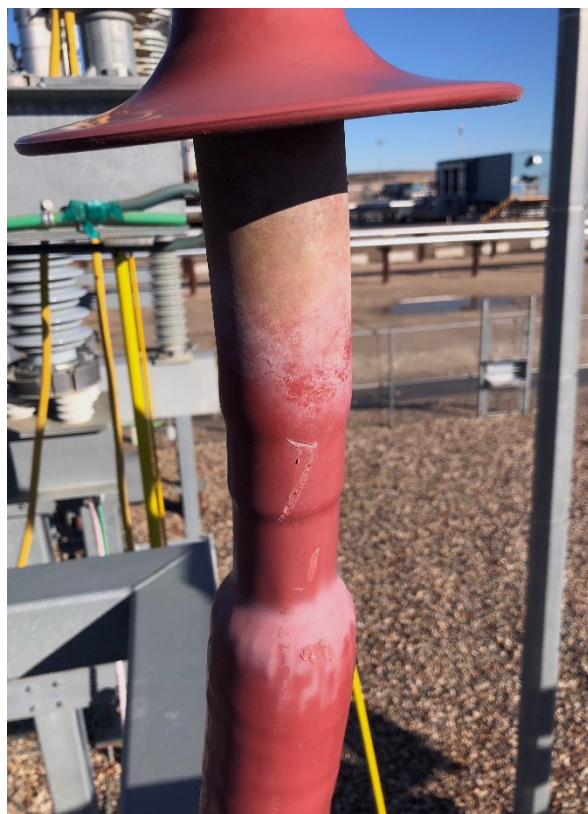
A high voltage asset owner in central Canada has numerous terminations on substation structures. Clearly salt contamination is not the issue. However other contamination is building up unevenly on their terminations.

Cable termination H3 with uneven contamination

During the next scheduled outage, the insulators were cleaned and then rescanned. The ultrasonic energy was gone, proving that the discharge was a result of the contamination.

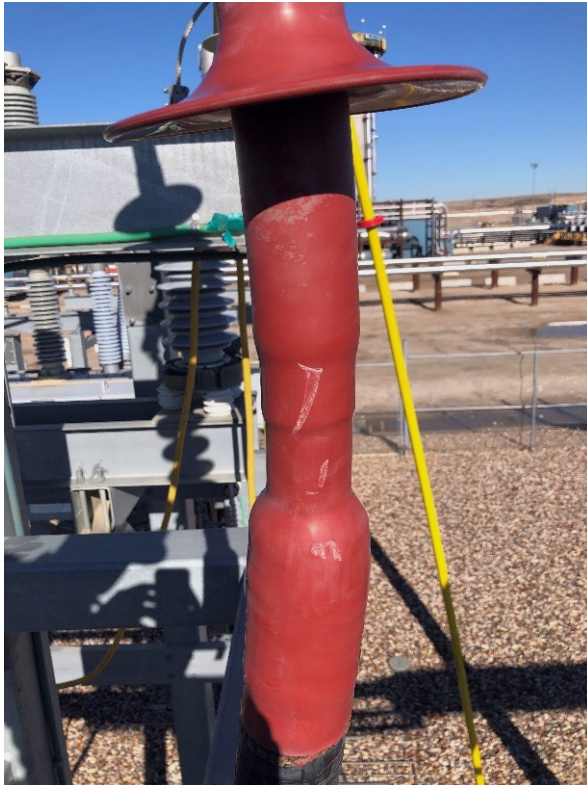
Cable termination H3 after cleaning

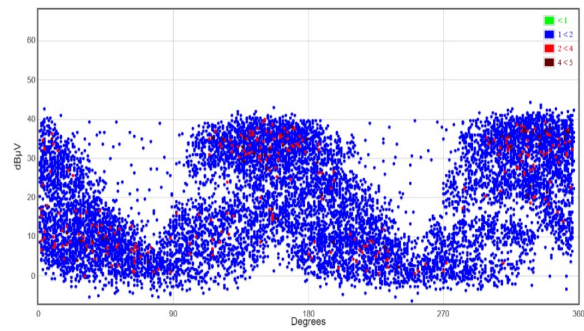
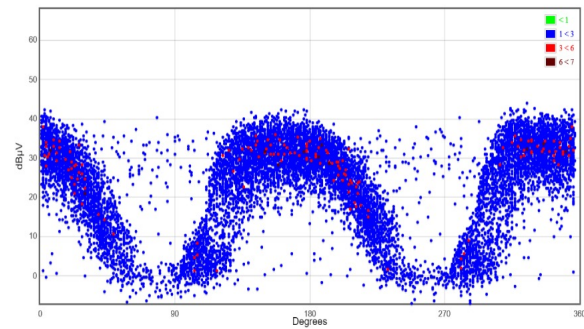
Two of the terminations (H1 and H3) scanned returned very high levels of ultrasonic energy. The phase resolved plots show typical PD results. The source is frequency locked to the power system and the impulses are occurring twice a cycle, half a cycle apart.

The levels are approaching 40dBuV which is very high. The ANSI/NETA MTS 2019 standard calls for immediate action on levels greater than 6 dBuV.

Ultrasonic PD results prior to cleaning

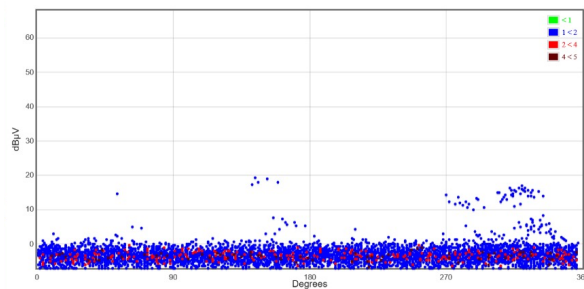
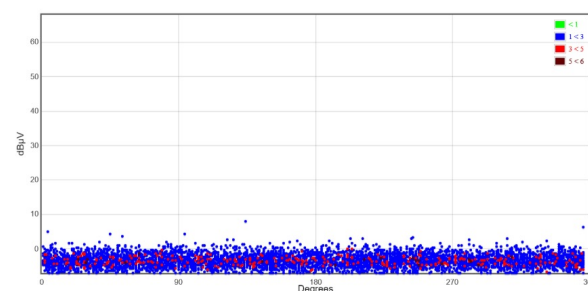
Ultrasonic PD results after cleaning
