REPORT

# Partial Discharge Survey Examples of MV and HV Assets

Prepared for: Customers  
Document Version: 1  
Date: 17 October 2016

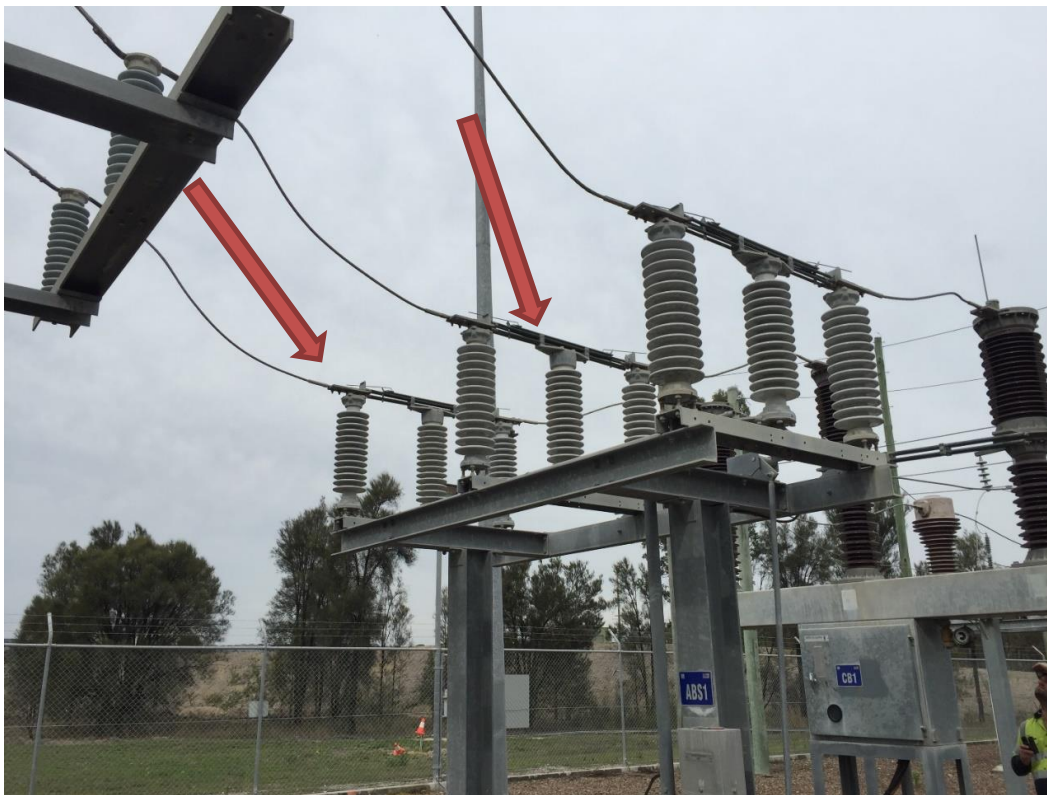
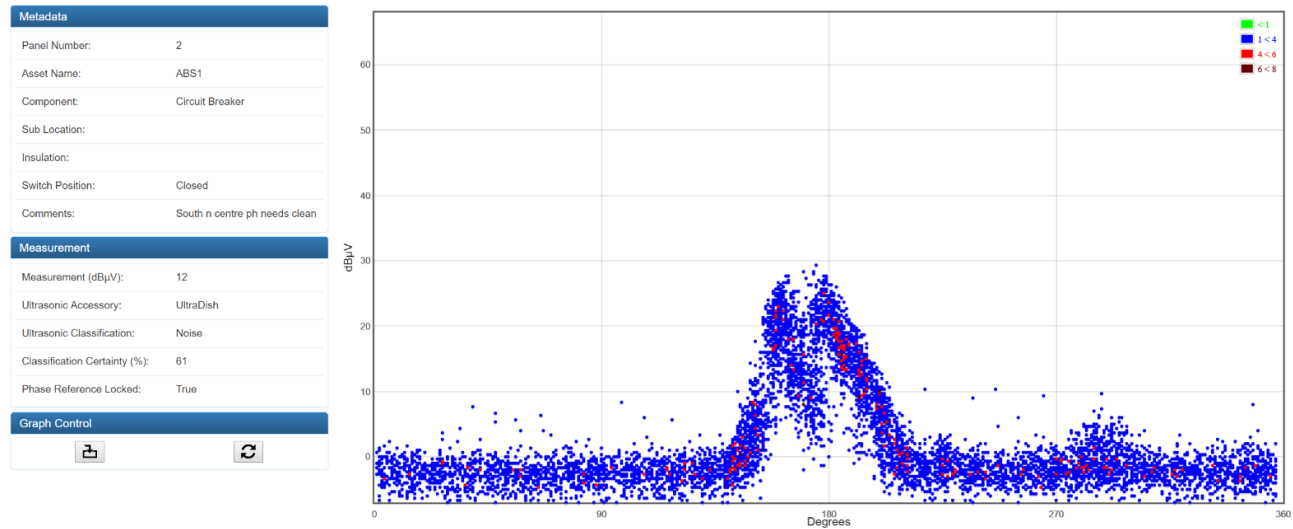
Figure 1 ABS1

The south and center phase insulators on ABS1 were emitting ultrasonic activity that is consistent with non-destructive corona activity. See Table 1Figure 1. Table 1Figure 2 is the trace captured during the scan and does not indicate PD. Given the nature of the exposed metalwork, metallic sharp points and the single cluster of activity on the phase resolve plot, this source is classed as non-destructive corona - no action required.

**Figure 2** Ultrasonic trace from ABS1 showing Corona Discharge

- C1. Non-destructive corona found on ABS1 inside SR001 substation.
- C2. Ultrasonic surface discharge activity detected on centre phase of 66kV CB1. This activity was not present after a day of rain in the area – this proves that the surface discharge activity was caused by surface contamination from the atmosphere.

- R1. The corona found on ABS1 inside SR001 is of no concern as it is in open air.
- R2. The surface discharge activity on 66kV CB1 is unlikely to have caused any damage to the porcelain insulation system of the circuit breaker. At the next available shutdown, it is recommended to closely inspect the porcelain for any signs of damage.
- R3. The corona found on ABS3 inside SR001 is of no concern as it is in open air.

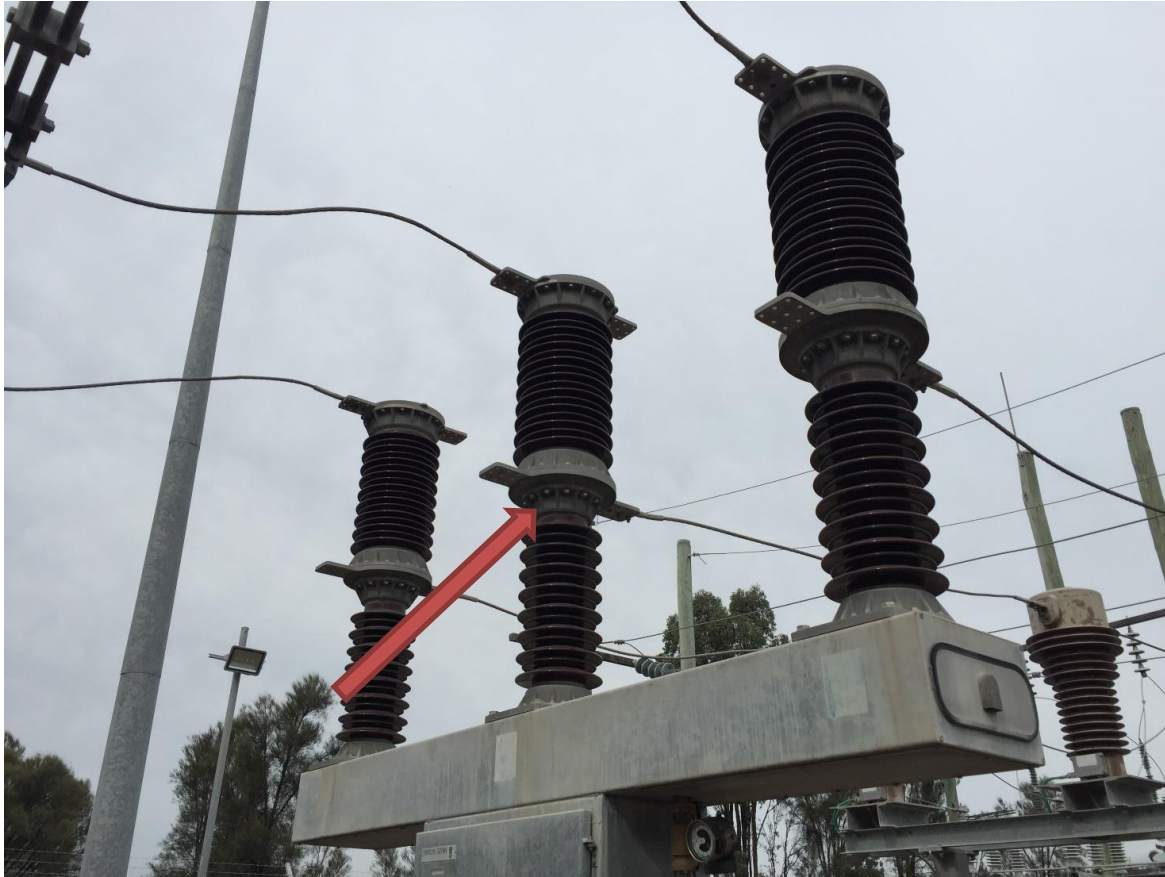
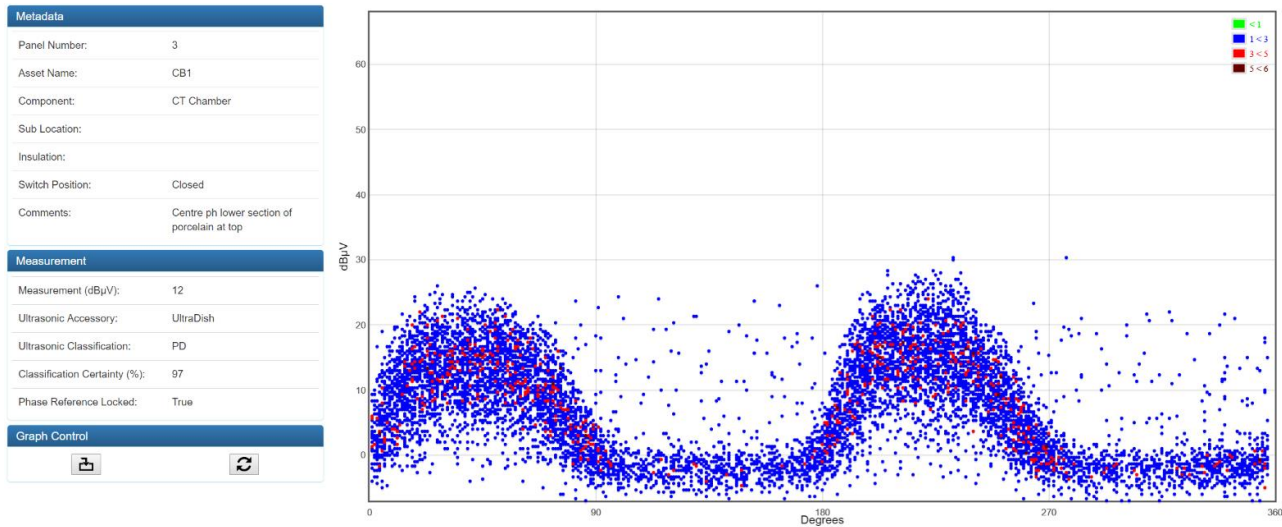
Figure 3 CB1

An ultrasonic source of surface discharge was detected on the middle of the center phase bushing on CB1. See Figure 3. With readings up to 12dBuV which was also phase resolved (activity 180 degrees apart,) this is classed as a strong surface discharge source. See Figure 4. To rule out any internal type PD happening within the 66kV CB. Given that the construction of the CB being porcelain, surface contamination is highly unlikely to degrade the insulation system, however, at the next available shutdown, it is recommended to inspect the CB at this point of discharge.

Two days later, this CB was revisited after heavy rains the previous day. Another ultrasonic scan was performed and all of the ultrasonic activity had disappeared. This confirms the above recommendation – all clear.

Figure 4 Ultrasonic trace from CB1 showing surface discharge activity

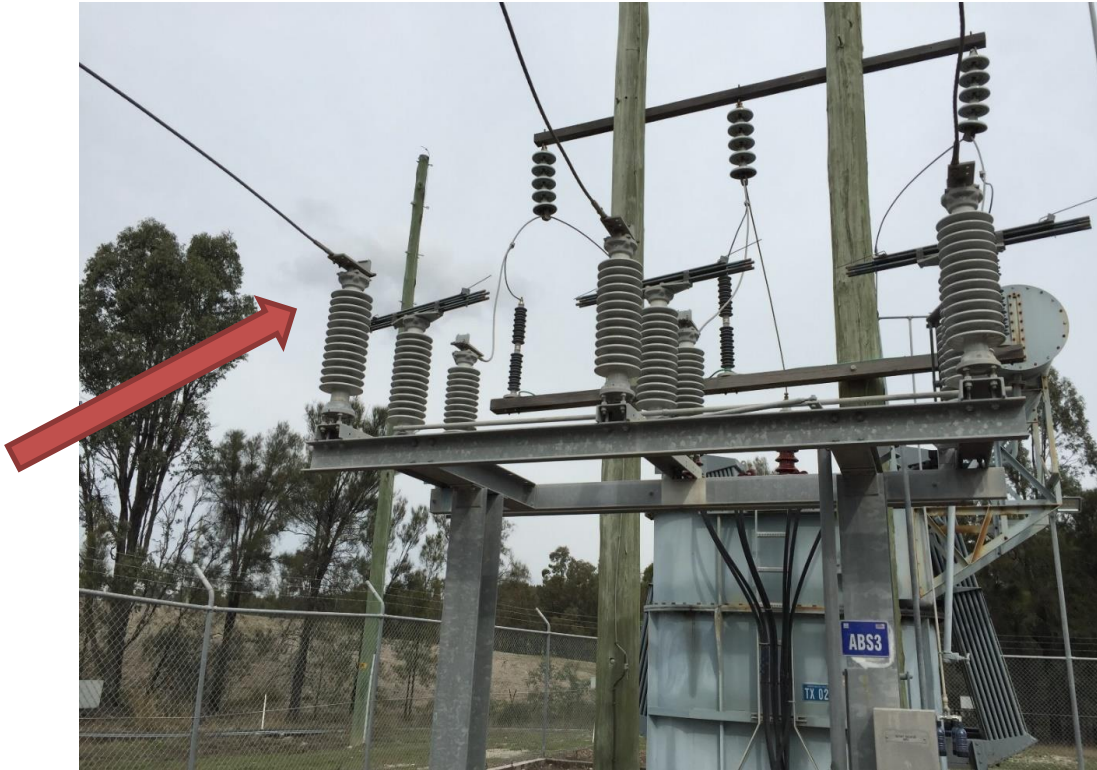
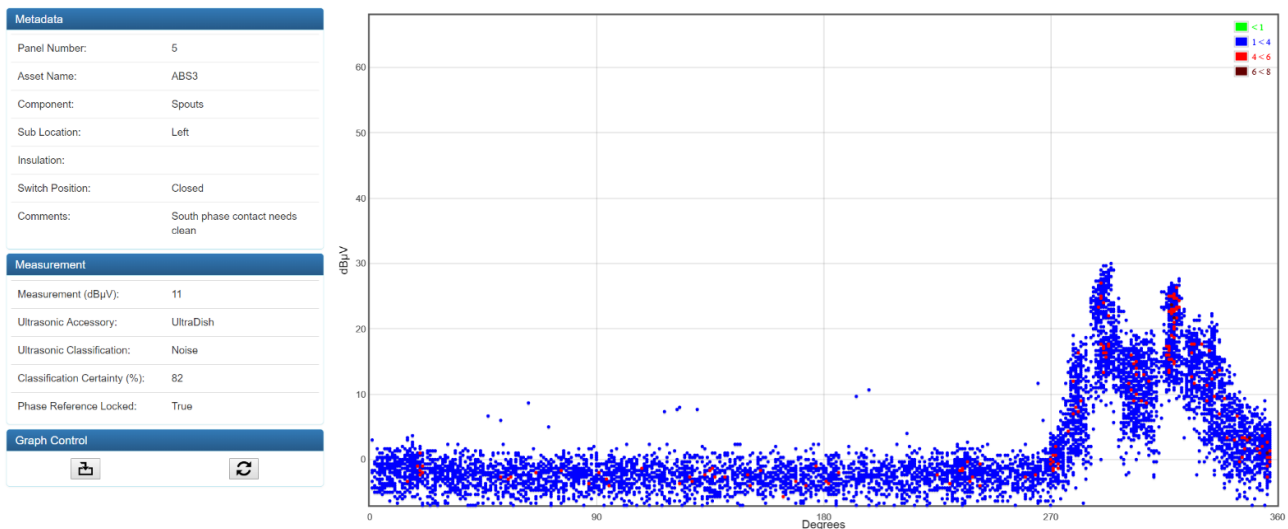
Figure 5 ABS3

An ultrasonic source of non-destructive corona was detected on the top of south phase insulator of ABS3. See Figure 5. The trace in Figure 6 is consistent with corona activity. Given the nature of the exposed metalwork, metallic sharp points and the single cluster of activity on the phase resolve plot, this source is classed as non-destructive corona – no action required.

Figure 6 Ultrasonic trace from ABS3 showing corona activity

- C3. Non-destructive corona found on ABS3 inside SR001 substation
- C4. A rusty nut and bolt at the base of the polymeric 66kV dropper insulator above TX021 on the north phase was located. This nut and bolt is emitting ultrasonic surface discharge activity.

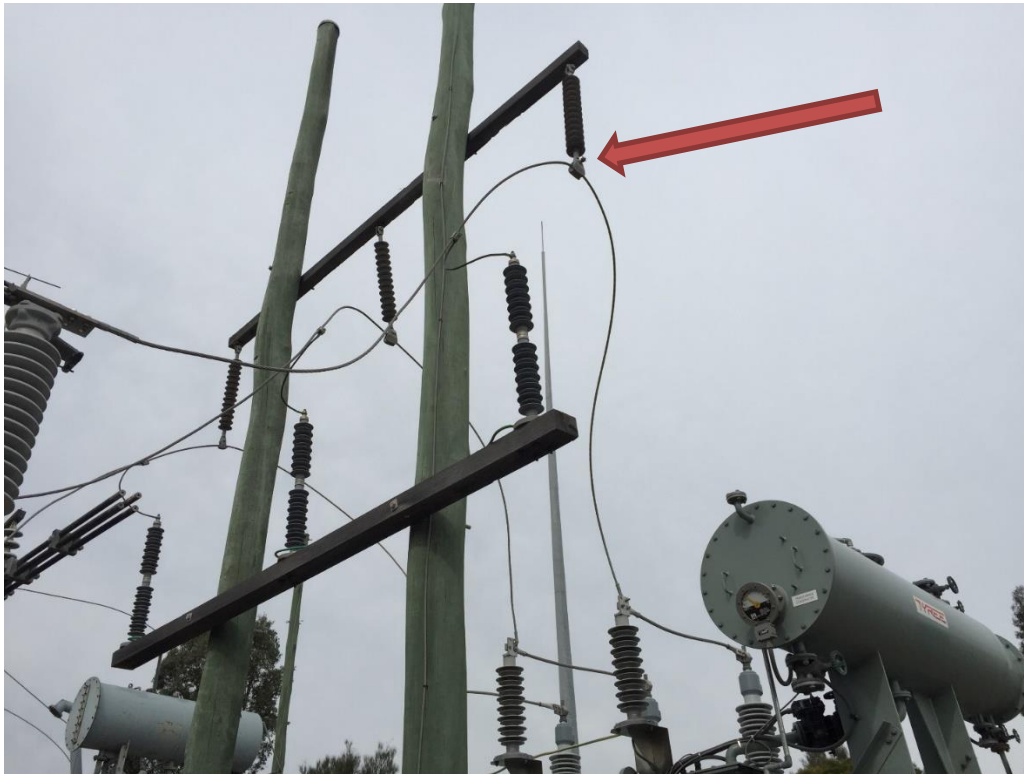
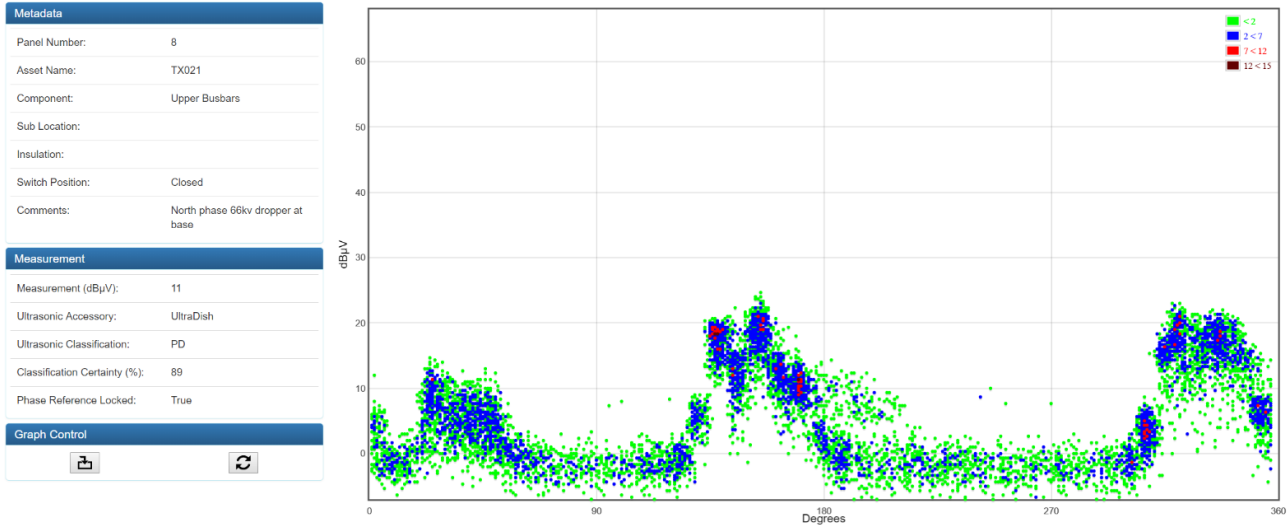
Figure 7 North phase 66kV dropper at TX021

There was ultrasonic surface discharge detected from the HV side of the north phase, 66kV dropper at TX021. See Figure 7. Upon closer inspection with binoculars, it could be seen that the nut and bolt that is holding the conductor clasp are rusty. This is likely giving the surface discharge activity that has been detected. Figure 8 is showing a trace consistent with surface PD. The polymeric insulation on the HV dropper may also be deteriorated because of the activity of the bolt.

**Figure 8** Ultrasonic trace from North phase 66kV dropper at TX021 showing surface PD activity

Recommend a close inspection of the polymeric insulator and replacement of the metallic hardware at the end of the insulator.

- R4. The rusty nut and bolt on the polymeric insulator above TX021 may be deteriorating and hence losing its mechanical strength. At the next available outage, it is recommended to replace the nut and bolt, replace any other faulty assets in its vicinity. Also, as polymeric insulation is more susceptible to surface damage than porcelain, the base of the polymeric insulator should be closely inspected for signs of degradation – replace if any degradation found.

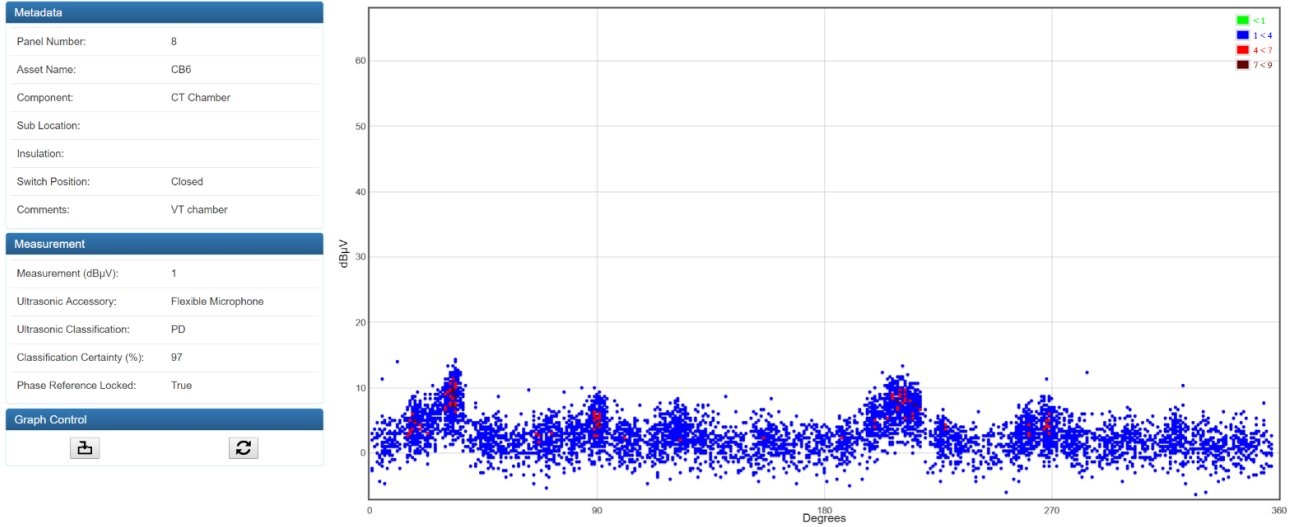
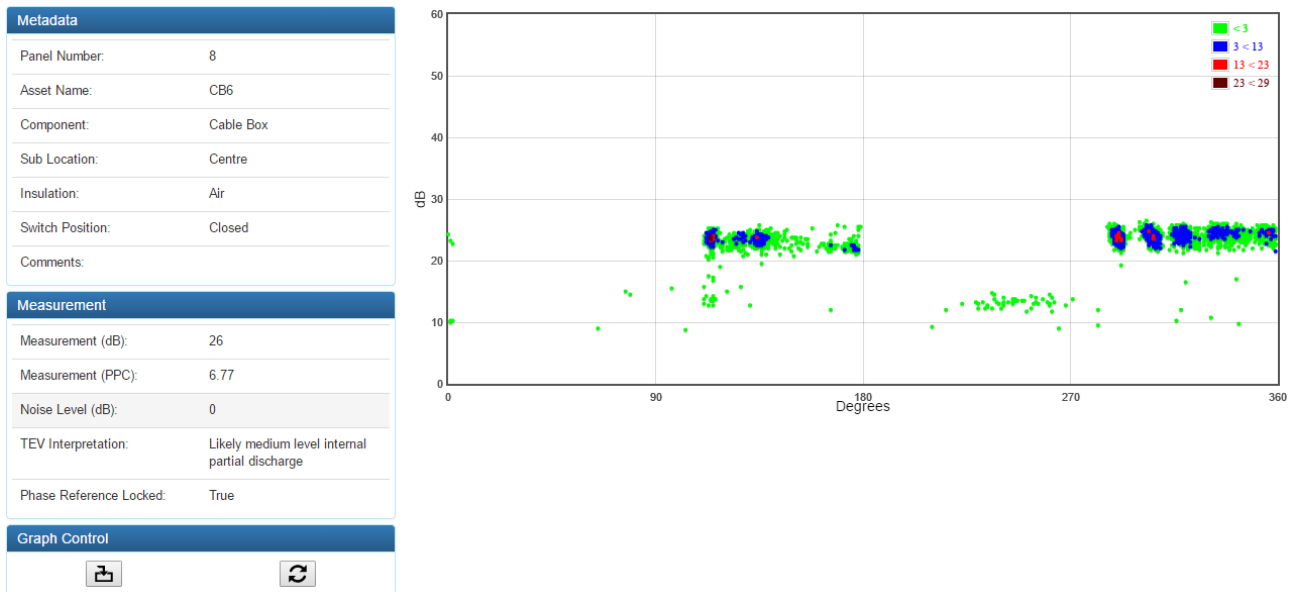
A potential source of partial discharge was detected from within the CB6 VT chamber. From examining the ultrasonic trace in Figure 9 and the TEV trace in Figure 10, the source detected does not indicate an internal void type discharge. It is more likely a 'contact' or 'floating metalwork' type discharge. Figure 10's trace is typical of contact type discharge where there are two flat lines of activity, 180 degrees apart. The activity that causes this trace is tiny sparks that flash across a physical gap between two conducting assets as the volts rise and fall per sin wave. The amplitude of the trace won't go above a certain level because the cause is tiny sparks across a gap of a certain length. Usually this type of activity does not cause any damage when it is not load related but it is always a good idea to investigate as it could indicate a poor HV connection and also because the contacts may be getting damaged from the constant sparking. This may be the contacts on the VT, HV fuses (if any) or any of the HV assets within this chamber not having the best connection. Check all clearances also. A crackling noise can be heard coming from behind the panel that also helps confirm it. This source is not a matter of urgency. Recommend inspect during the next maintenance period.

Figure 9 Ultrasonic results from CB6 VT chamber showing PD surface activity

Figure 10 TEV results from CB6 VT chamber showing internal PD activity

- R5. Although not urgent, it is recommended that at the next available outage, the VT chamber panel on CB6 inside SR001 substation should be removed and all HV assets within this chamber be inspected for signs of a ‘contact’ or ‘floating metalwork’ type discharge. This may be poor HV connections somewhere in the panel. Clean the inside of the panel and all assets within. Repair / replace any damaged assets as required.

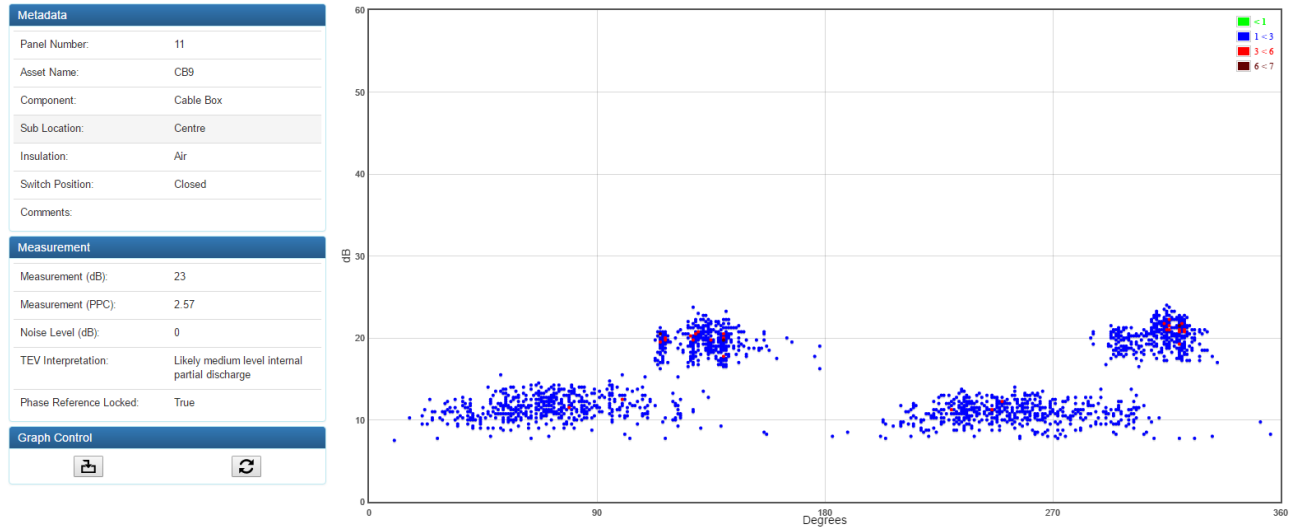
A minor source of internal PD has been detected from within the CB9 HV cable chamber. See Figure 11. This source is around 15dB and 2 pulses per cycle. It is at a low level at the moment so is of no concern in the near future. Recommend retesting in one years' time to compare results and look for any changes in amplitude. The PD trace is consistent with internal void type discharge. A visual inspection during the next shutdown period would be a good idea also but unlikely to see anything wrong as the activity is consistent with internal void type PD. No ultrasonic noise could be heard here which likely rules out surface tracking.

Figure 11 Internal PD results from CB9 HV Cable Chamber

- C6. An internal void type discharge of a low level was detected coming from the HV cable chamber of CB9 inside SR001 substation.
- C7. Non-destructive corona found on CB-Q100 on top of TX045 substation.

- R6. As the PD source within the HV cable chamber of CB9 is an internal void type discharge, it is unlikely that a visual examination will find any defects. However, recommend a visual examination of this chamber if an outage allows. Recommend re-test in one years’ time to compare any changes.

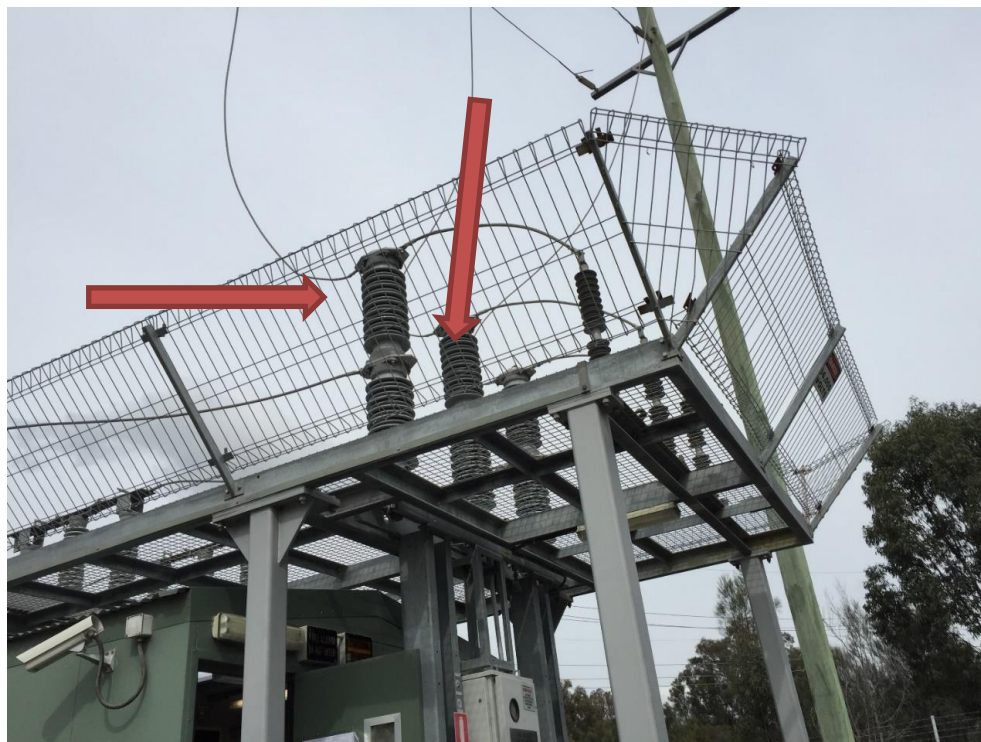
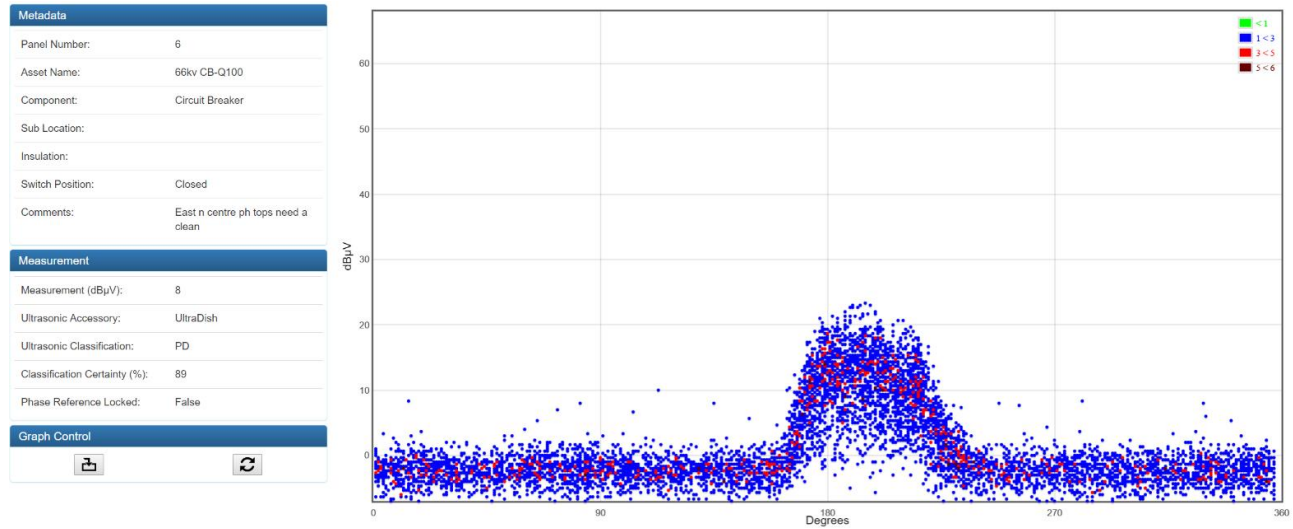
Figure 12 66kV CB-Q100

Corona activity was detected at the top of the two CB bushings as seen in Figure 12. This is of no concern as corona on outdoor switchgear is non-destructive.

**Figure 13** Ultrasonic results from 66kV CB-Q100 showing corona activity

- R7. The corona found on CB-Q100 on top of TX045 substation is of no concern as it is in open air.
- R8. The corona found on Rotary switch S100 on top of TX045 substation is of no concern as it is in open air.

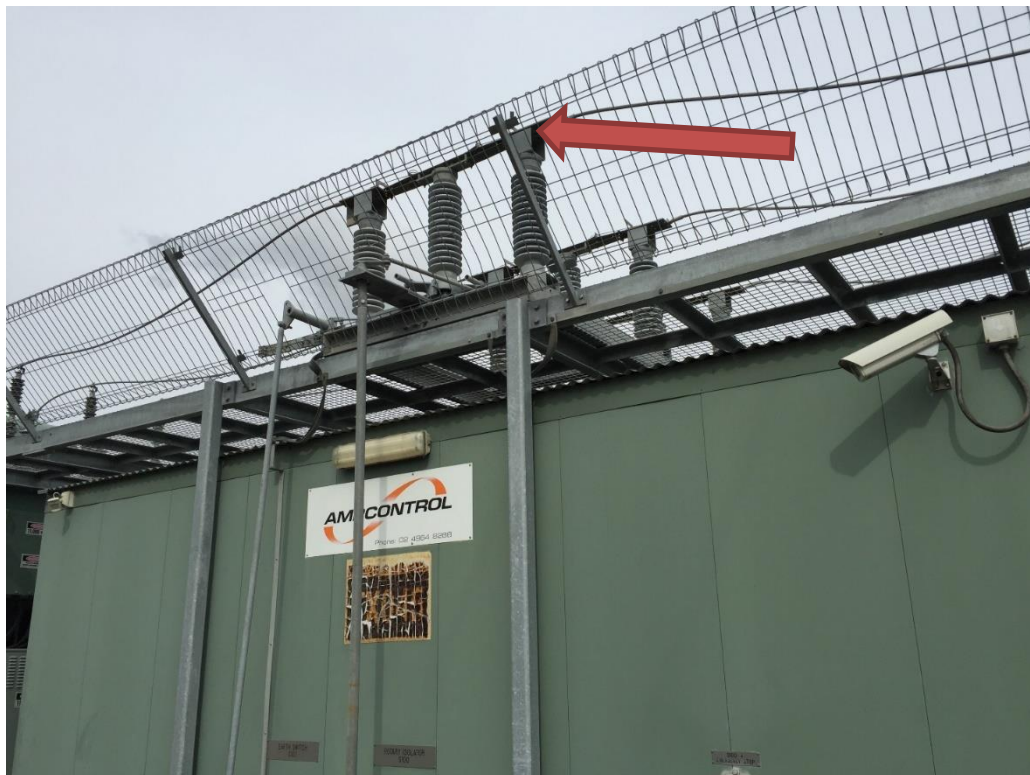
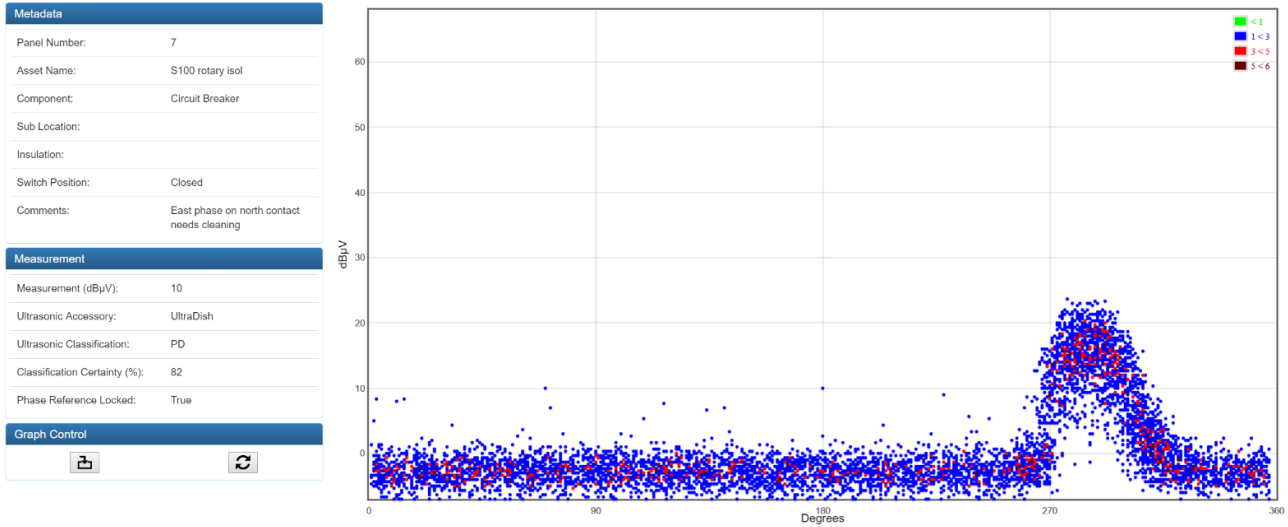
**Figure 14** 66kV S100 Rotary Isolator

Corona activity was detected at the top of the rotary isolator bushing as seen in Figure 14. This is of no concern as corona on outdoor switchgear is non-destructive.

Figure 15 Ultrasonic results from 66kV S100 Rotary Isolator showing corona activity

- C8. Non-destructive corona found on Rotary switch S100 on top of TX045 substation.
- C9. A low level ultrasonic source of discharge was found coming from within the TX074 11kV Cable Box.

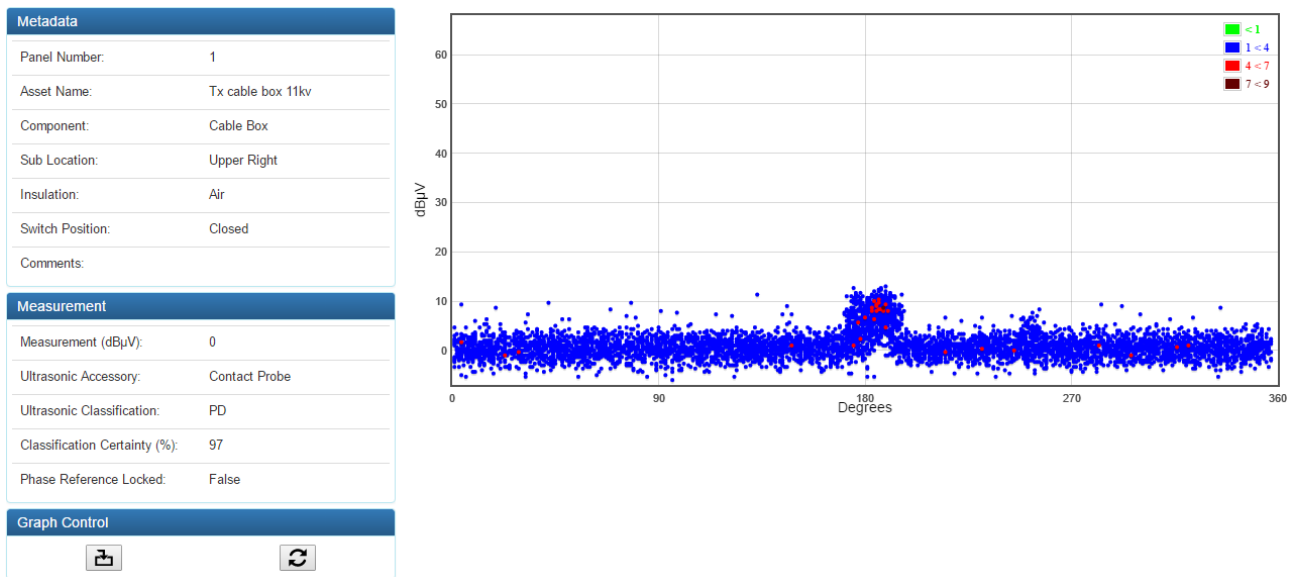
There was an ultrasonic source located to within the 11kV Cable Box of TX074 using the Ultra Contact Probe. It gave readings on average of 0dBµV (the scale starts at -7dBµV.) This indicates a low level but the HV asset ideally would not be making any noise at all. The audible noise recorded sounds like surface tracking somewhere on the HV assets. Recommend inspect during the next maintenance period. Look for signs of tracking on all HV assets especially the HV conductors. Check all clearances are adequate also.

Figure 16 Ultrasonic trace from TX074 11kV Cable Box

- R9. It is recommended that at the next available outage, this 11kV cable box be inspected for any signs of surface tracking on all HV assets within. Check all clearances to earth straps also. If any signs of tracking are found on the cables, plan to re-terminate the cable. Check for closely crossed phases and the gaps between this insulation.

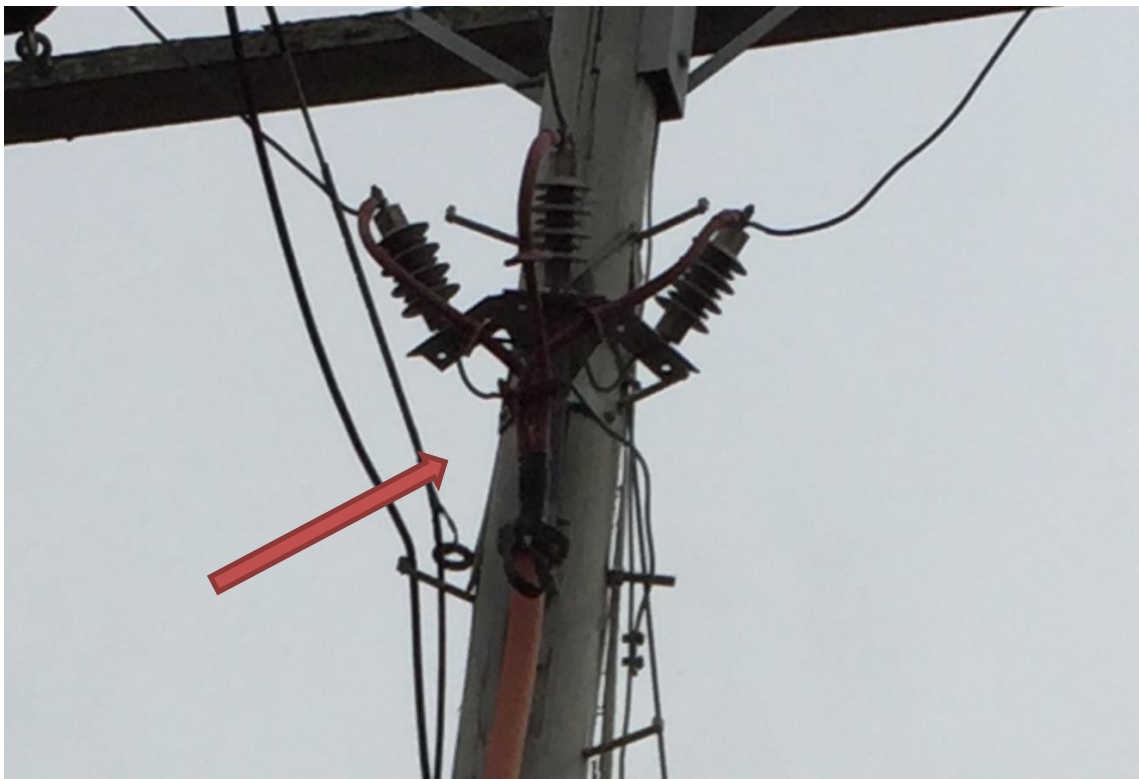
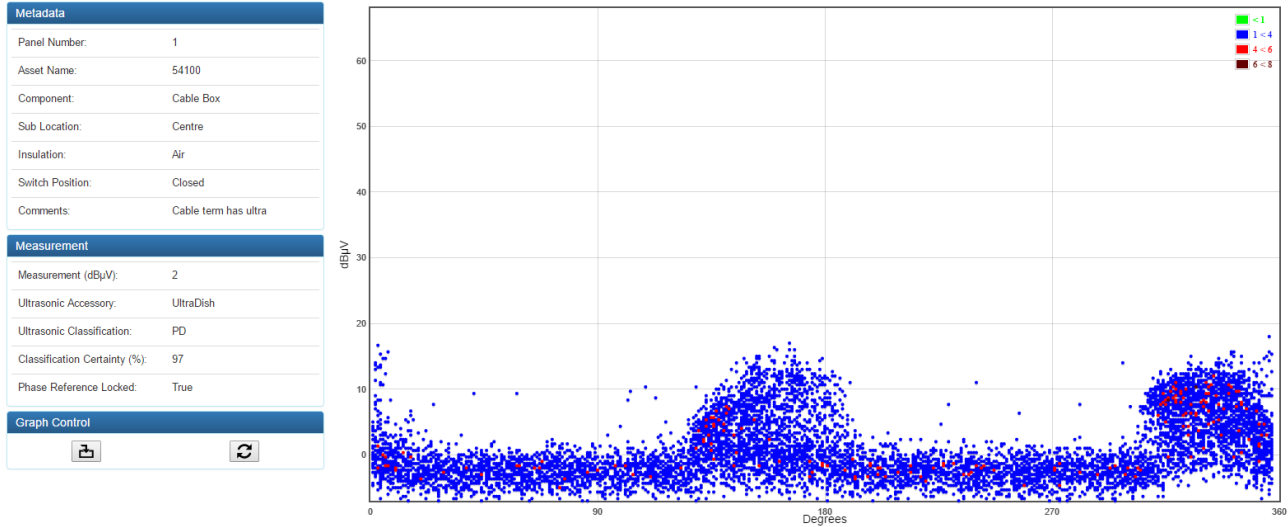
**Figure 17** Cable head termination 54100

**Figure 18** Ultrasonic results from Cable head termination 54100 showing Surface PD Activity

- C10. An ultrasonic surface discharge source was detected from above the crutch of HV cable head termination 54100. On closer inspection, it can be seen that two of the three HV phases are crossed over in very close proximity to one another. This is likely to cause a point of high electrical stress which can cause surface partial discharge at this point. After a day of rain, the surface discharge source was no longer present.

It is recommended at the next available outage to closely inspect the termination for any surface discharge activity between the crossed phases. If any damage is visible, the damage is not repairable. Plans should be put in place to replace the HV termination. Also inspect the ground / bonding connections to make sure they are tight and clean.

- R10. The HV cable head termination 54100 should be closely inspected at the next available outage. Attention should be paid to the area where the two phases cross one another. If any signs of surface tracking are found, plans should be put in place to re-terminate the HV cable.

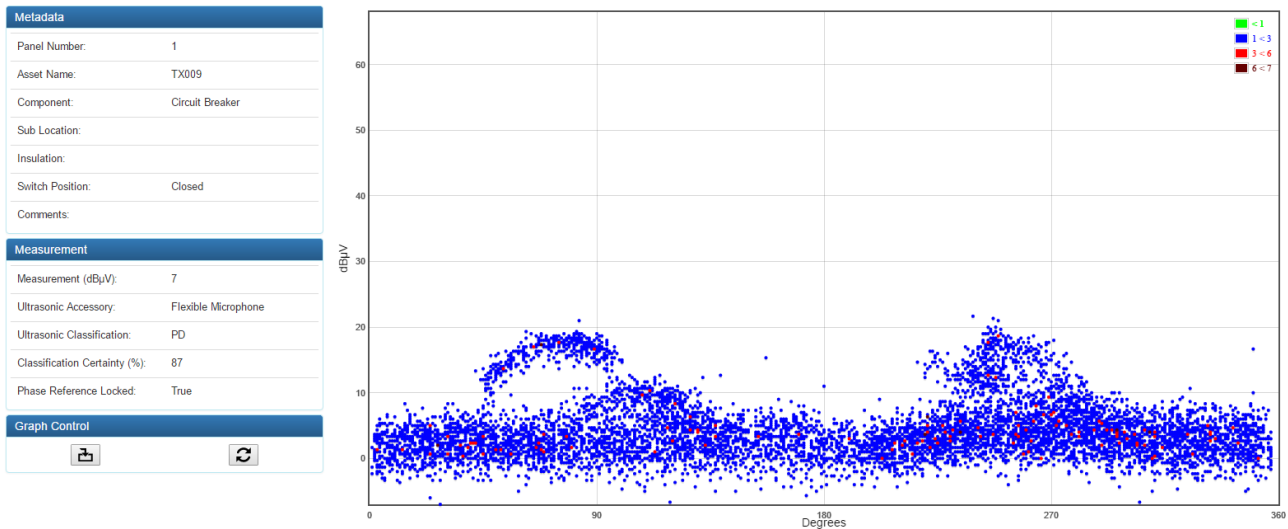
An ultrasonic discharge source was detected coming from behind the HV CB at TX009. Upon visual inspection of the HV chamber, it was picked up that the ‘B’ HV connection on the 11,000/110V voltage transformer was covered in green verdigris. This contact is very likely the source of ultrasonic activity. This contact needs to be cleaned and ideally replaced. If there is any surface tracking visible on the cast resin part of the VT, the VT should be planned to be replaced. The whole HV chamber should be inspected for any other evidence of surface tracking – the VT connection may not be the only source.

**Figure 19** Ultrasonic data recorded from TX009 showing PD activity

- C11. An ultrasonic source of surface tracking was detected coming from behind the HV CB at TX009. A visual confirmation has found the likely source. It was seen that the ‘B’ HV connection on the 11,000/110V voltage transformer was covered in green verdigris.

- R11. It is recommended that at the next available opportunity, the ‘B’ HV contact on the VT inside TX009 substation be cleaned up with plans to be replaced. If this is not possible, consider replacement of the VT. Also, the cast resin insulation around the HV contact should be closely inspected for signs of surface tracking. If this is the case, plans should be put in place to replace the VT as the damage is not repairable. Inspect the rest of the HV chamber as the VT contact may not be the only source of PD.

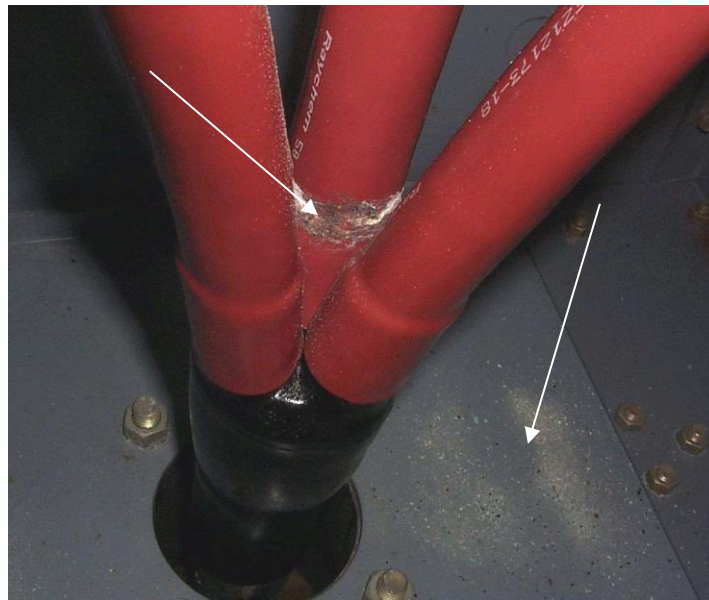
**Figure 1** Surface discharge activity between cable phases.

Note that white power in the base of the cable box or on horizontal surfaces is a good indication that discharge activity is present within switchgear.

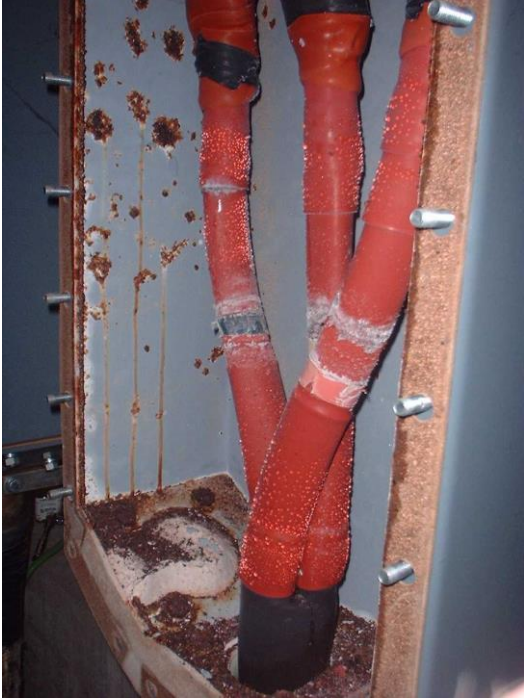
**Figure 2** Evidence of advanced discharge activity within an 11kV switchgear air insulated cable box.

Note the extensive rusting of steel box due to the formation of nitric acid within box as a result of partial discharge activity.

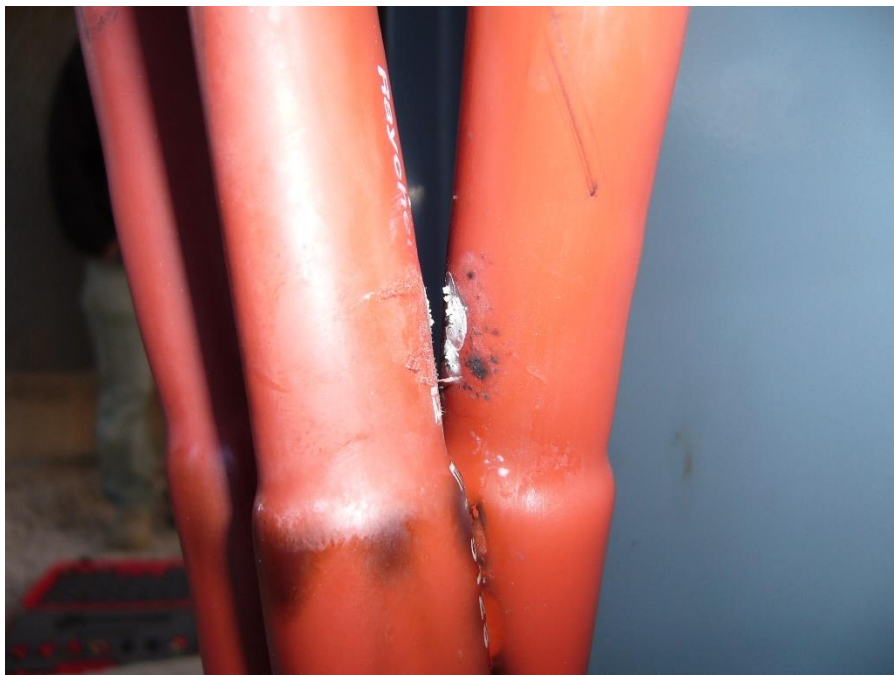
**Figure 3** Discharge activity between cable phases within an air insulated cable box.  
Note white powder deposit on polymeric surfaces.

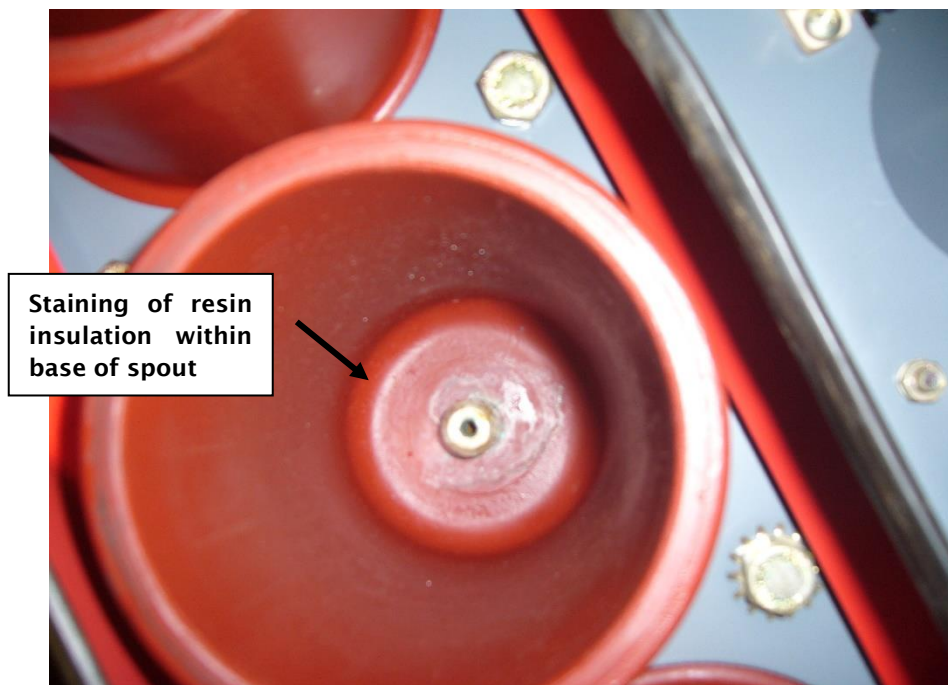
**Figure 5** Staining of resin insulation within 11kV circuit breaker spout caused by the effects partial discharge activity

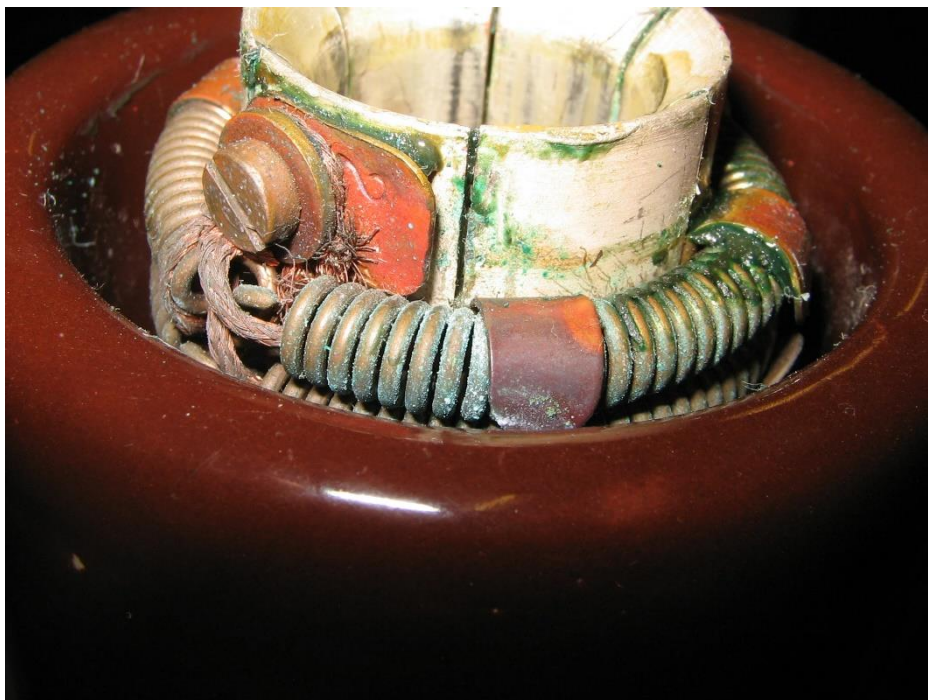
**Figure 7** Evidence of discharge activity within a porcelain contact cluster of an 11kV circuit breaker.  
Note the green corrosion product on the surface of the contact cluster.
