# Partial Discharge Survey of Interruptible and Sub 1 Switchgear

Prepared for: Customers  
Document Version: 1  
Date: 8 June 2018

EA Technology was requested to perform an online Partial Discharge survey of switchgear located at XYZ facility using the UltraTEV Plus2. Transient Earth Voltage (TEV) and Ultrasonic testing was performed.

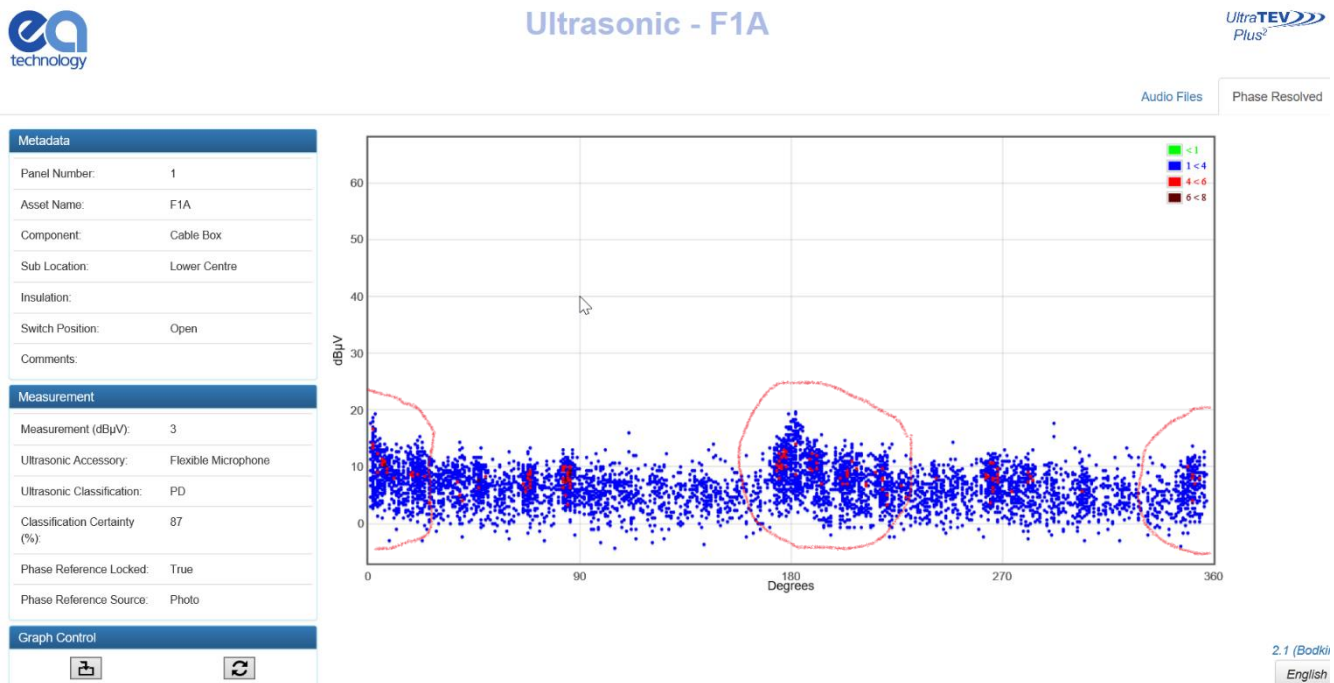
Substation 1 Bay F1A had evidence of low level Ultrasonic (surface) PD in both the front (figure 3) and rear (figure 2) lower sections. The audio capture also provides supporting evidence that there is activity in the PD spectrum.

As the gear was energized we could not investigate further. The F1A breaker was open at the time of the testing with the load being carried through the F1B breaker. At this time there is no immediate concern, but this gear should be retested in 3-6 months monitoring for any increase in PD levels and during the next outage offline testing and/or a visual inspection of the F1A gear should be performed looking for evidence of surface partial discharge. Considering the age of the gear possible sources can include wear of the breaker components (breaker stabs etc.), surface contaminants on the inside of the gear or age-related deterioration of insulators as can be expected on 50-year-old equipment.

It was noted that the recorded humidity was low at 27%RH. Surface PD is directly influenced by the amount of relative humidity. Retesting at a time when the humidity is higher could result in greater levels of PD. If the measured PD increases with the relative humidity this will further support the presence of surface PD.

Figure 2 Ultrasonic trace from Sub 1 F1A cable compartment (Rear): Classification- PD (Surface)

- R1. Interruptible Substation: Retest in 2 years.
- R2. Substation 1: Retest every 3-6 months and monitor levels. If switchgear is taken out of service perform additional testing, visual inspection for evidence of PD and/or off line PD testing.

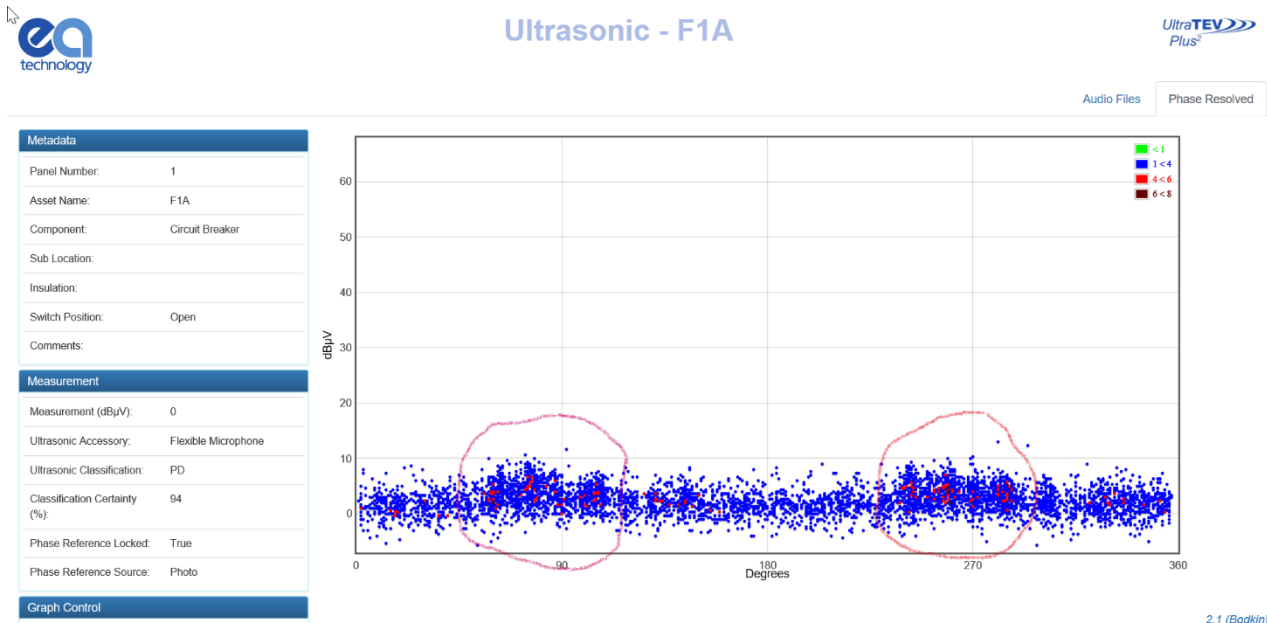
Figure 3 Ultrasonic trace from Sub 1 F1A circuit breaker (Front): Classification- PD (Surface)

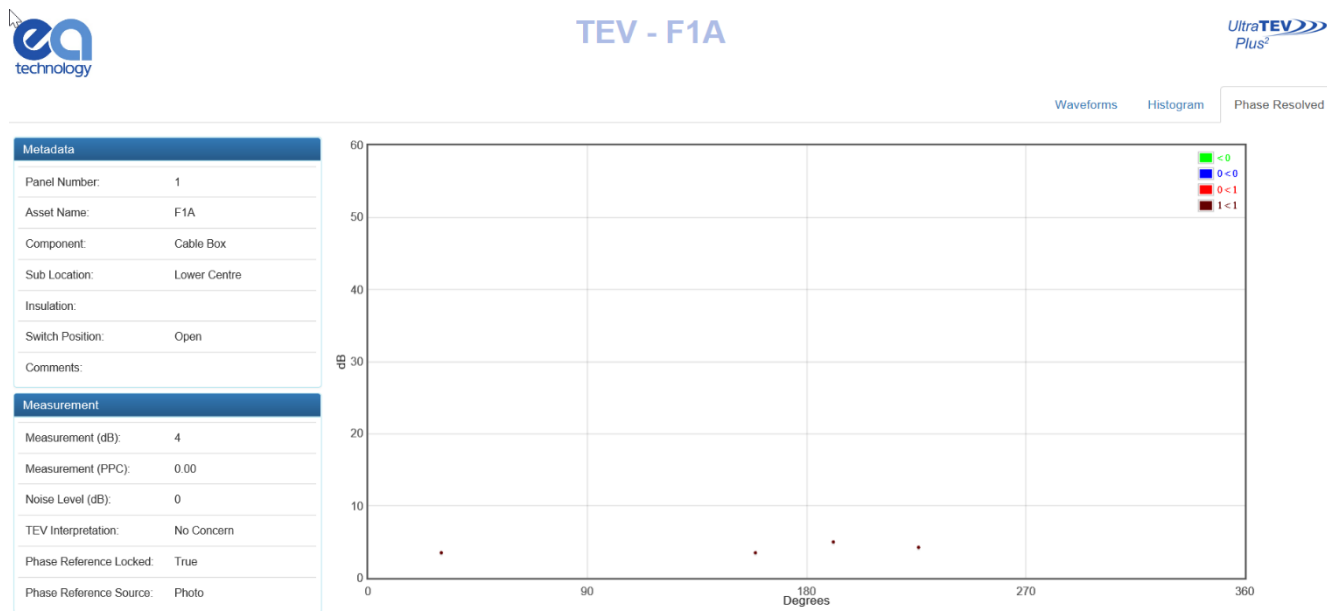
Figure 2 TEV phase resolved plot from Sub 1 F1A cable compartment (rear): No internal PD evident

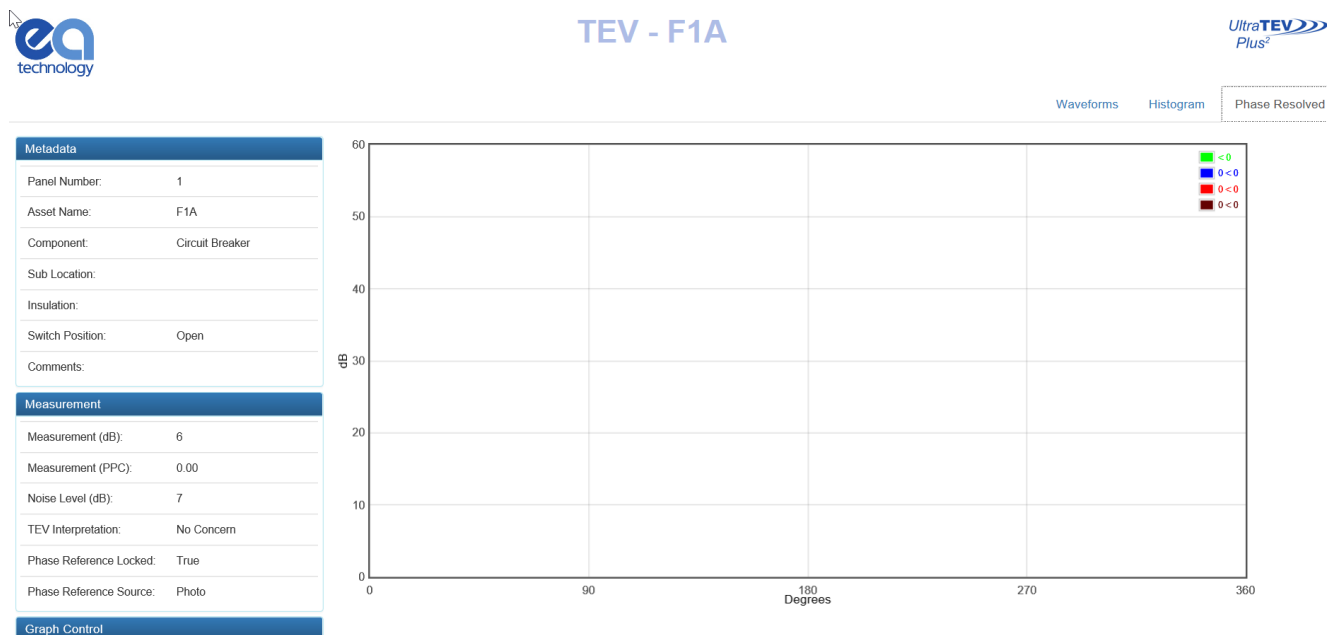
Figure 3 TEV phase resolved plot from Sub 1 F1A breaker compartment (front): No internal PD evident

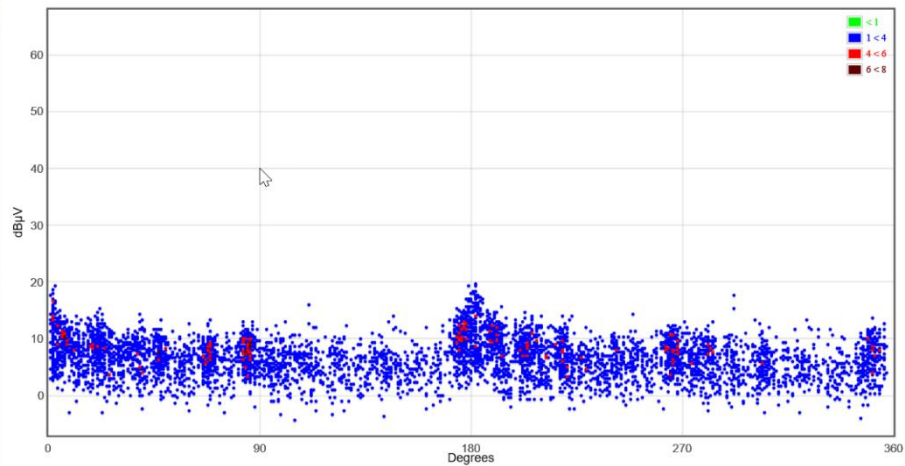
Figure 4 Ultrasonic phase resolved plot from Sub 1 F1A cable compartment (rear): Classification- PD (Surface)

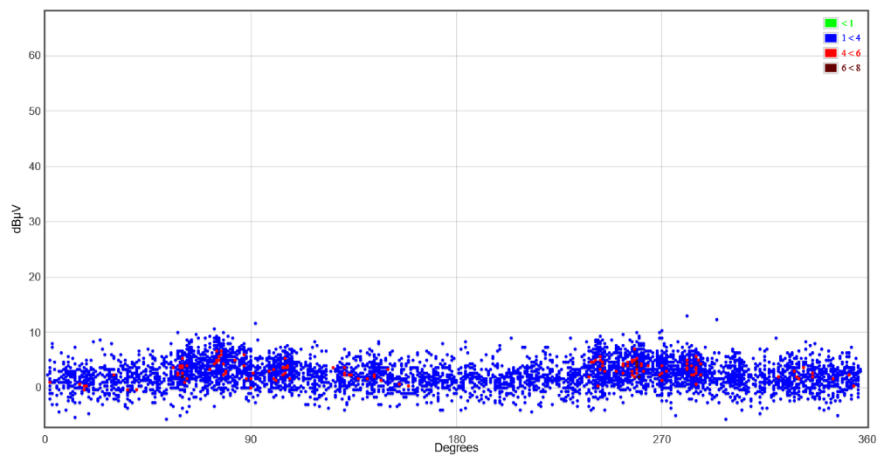
Figure 5 Ultrasonic phase resolved plot from Sub 1 F1A circuit breaker (front): Classification- PD (Surface)

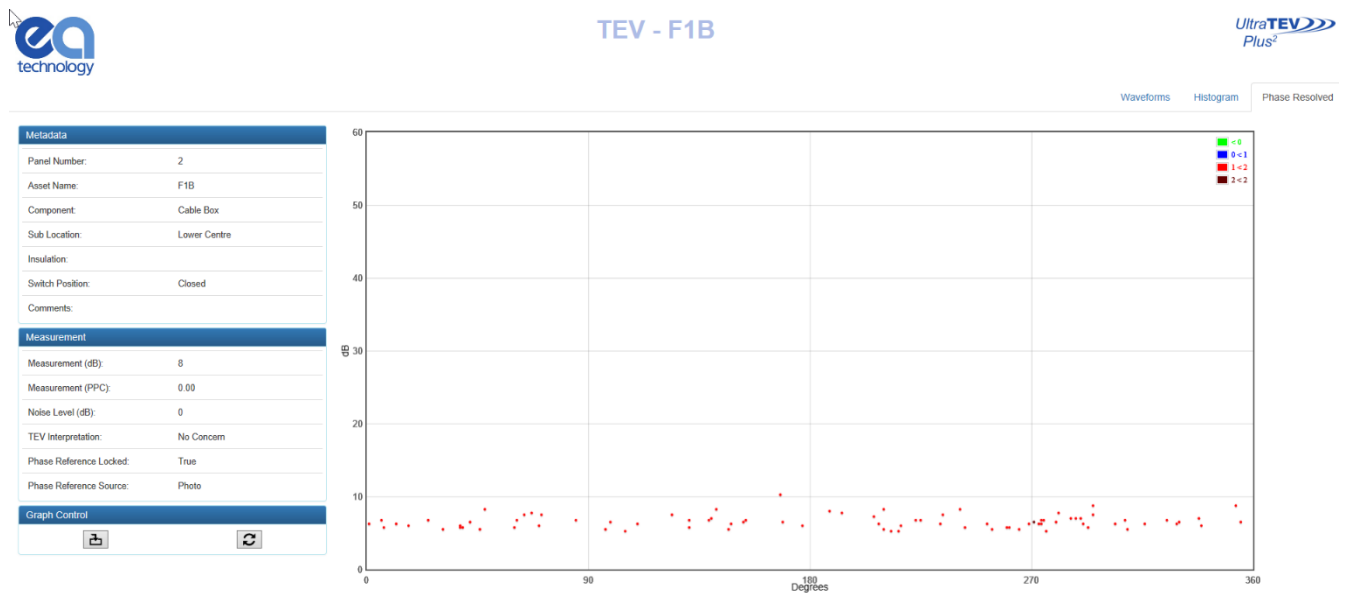
Figure 6 TEV phase resolved plot from Sub 1 F1B cable compartment (rear): No internal PD evident

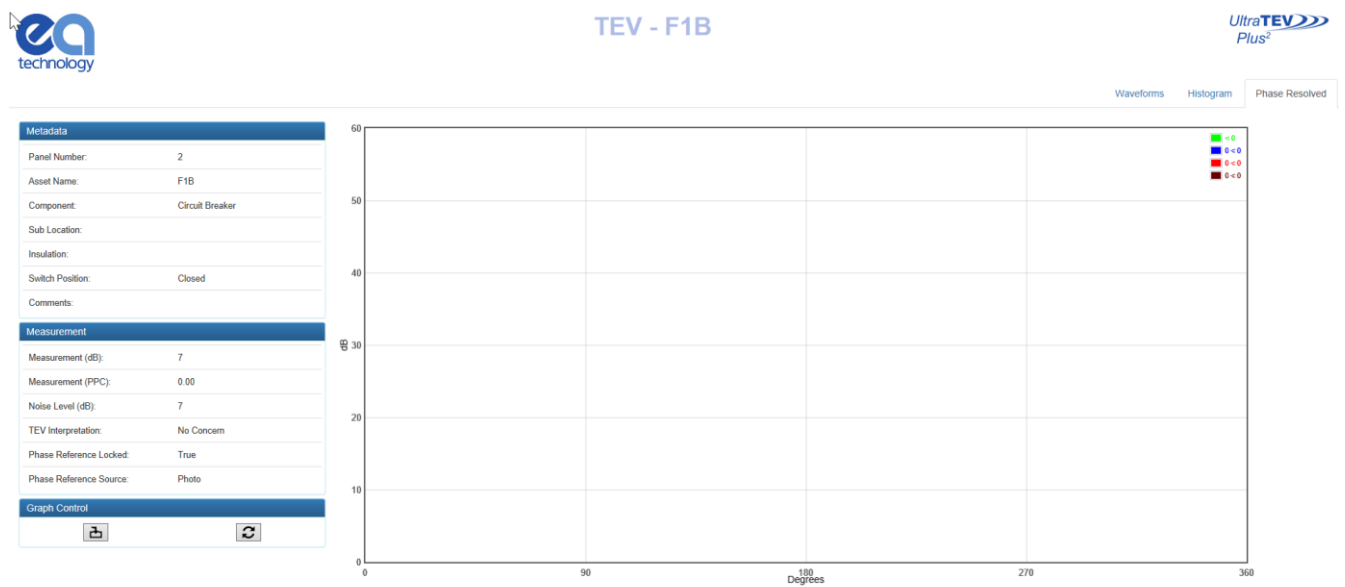
Figure 7 TEV phase resolved plot from Sub 1 F1B breaker compartment (front): No internal PD evident

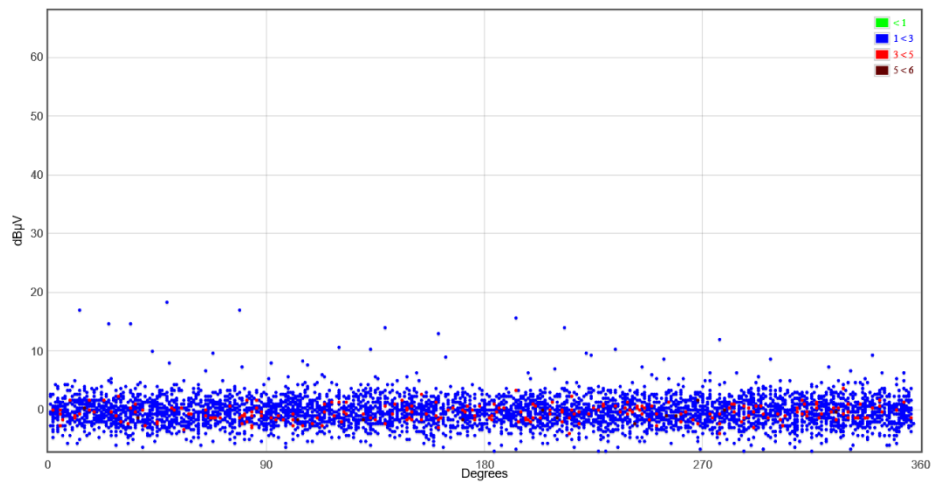
Figure 8 Ultrasonic phase resolved plot from Sub 1 F1B cable compartment (rear): Classification- Noise

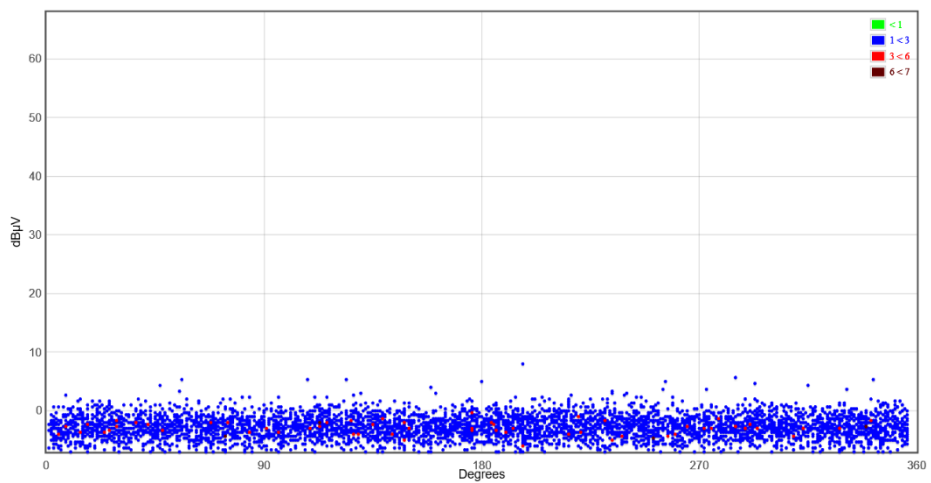
Figure 9 Ultrasonic phase resolved plot from Sub 1 F1B circuit breaker (front): Classification- Noise

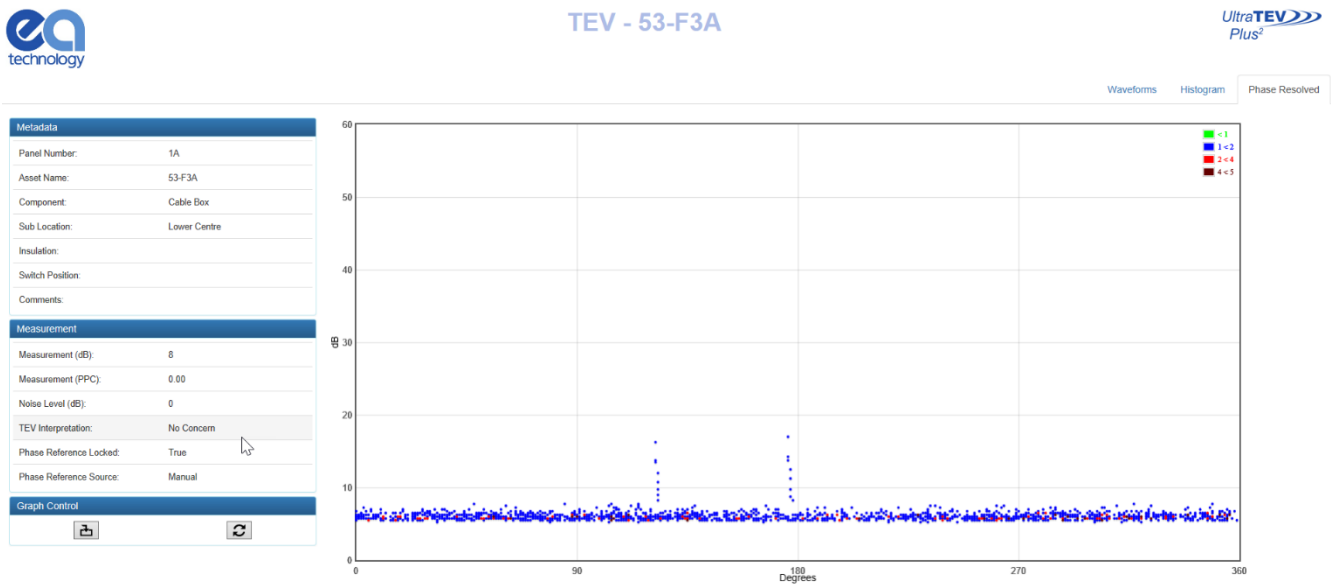
Figure 11 TEV phase resolved plot from Interruptible 52-F3A cable compartment (rear): No internal PD evident

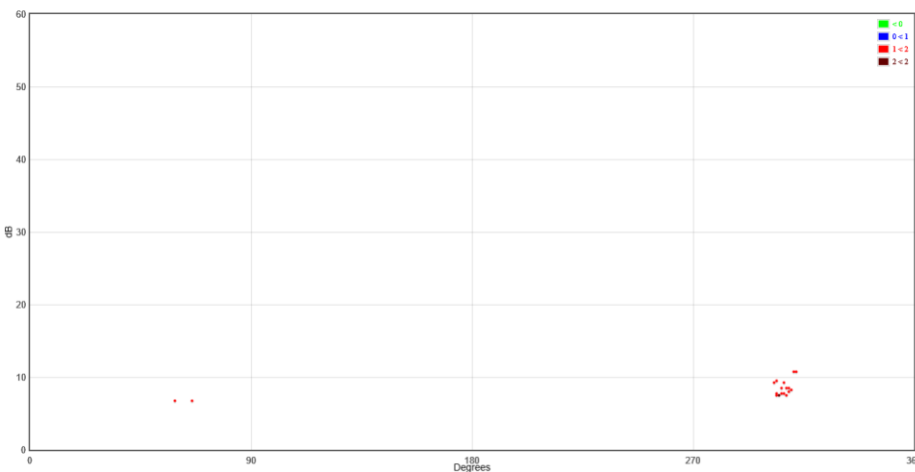
Figure 12 TEV phase resolved plot from Interruptible 52-F3A breaker compartment (front): No internal PD evident

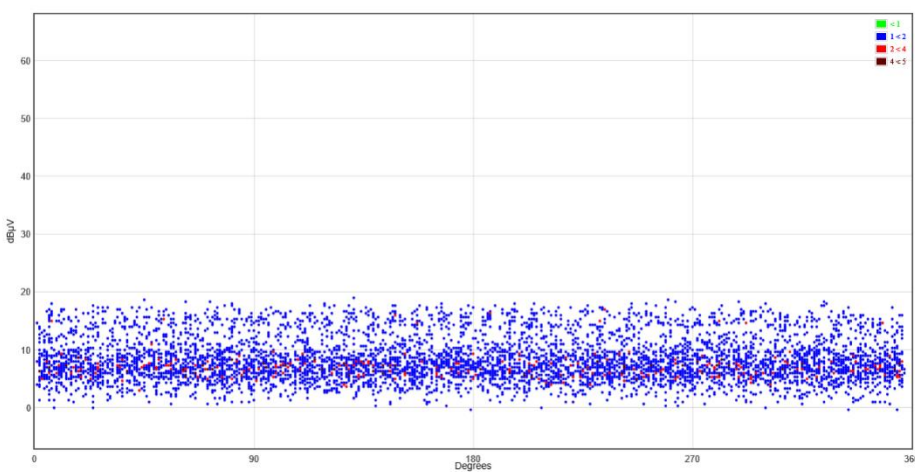
Figure 13 Ultrasonic phase resolved plot from Interruptible 52-F3A cable compartment (rear): Classification- Noise

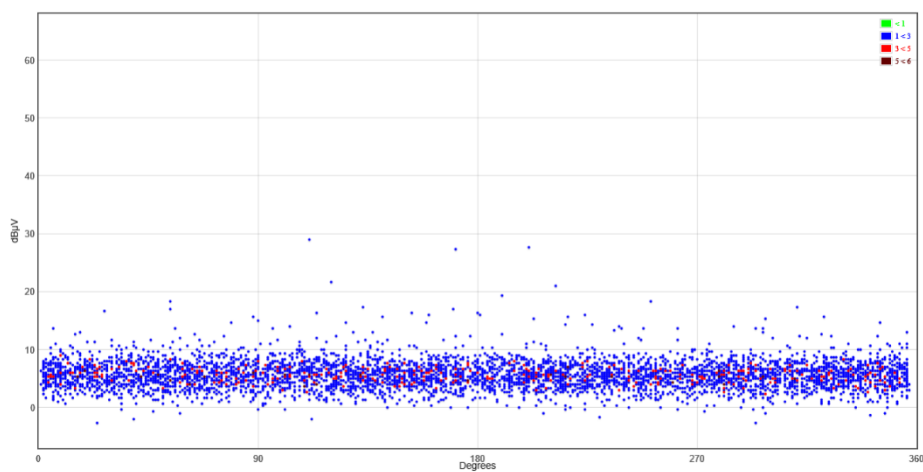
Figure 14 Ultrasonic phase resolved plot from Interruptible 52-F3A breaker compartment (front): Classification- Noise

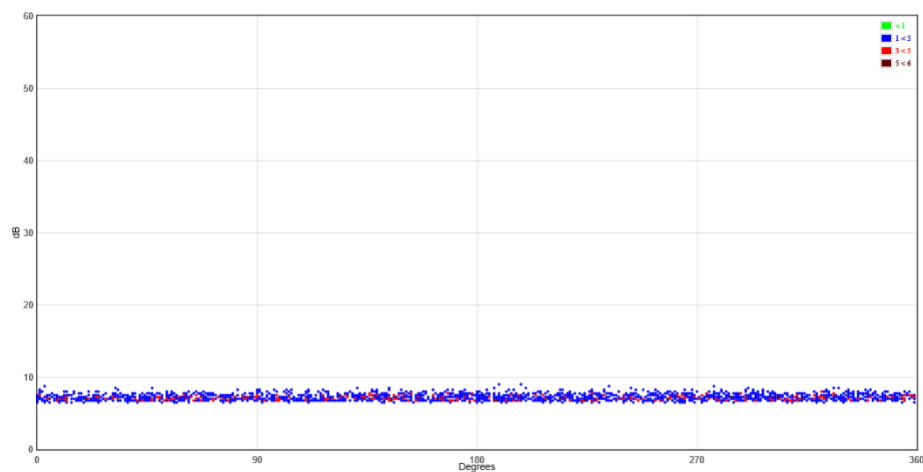
Figure 15 TEV phase resolved plot from Interruptible VT-UA cable compartment (rear): No internal PD evident

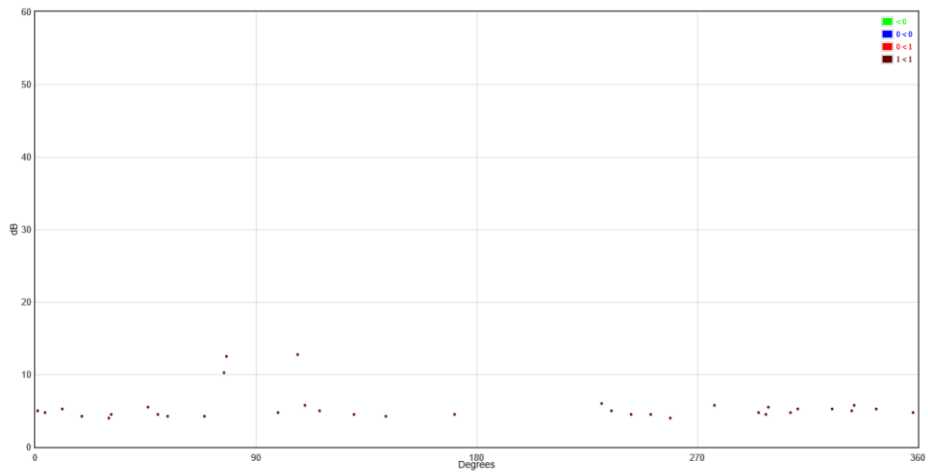
Figure 16 TEV phase resolved plot from Interruptible VT-UA PT compartment (Front): No internal PD evident

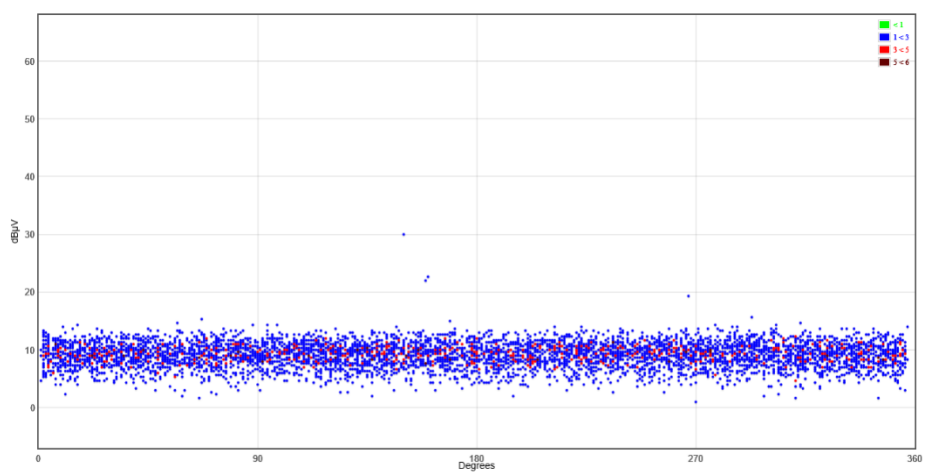
Figure 17 Ultrasonic phase resolved plot from Interruptible VT-UA cable compartment (rear): Classification- Noise

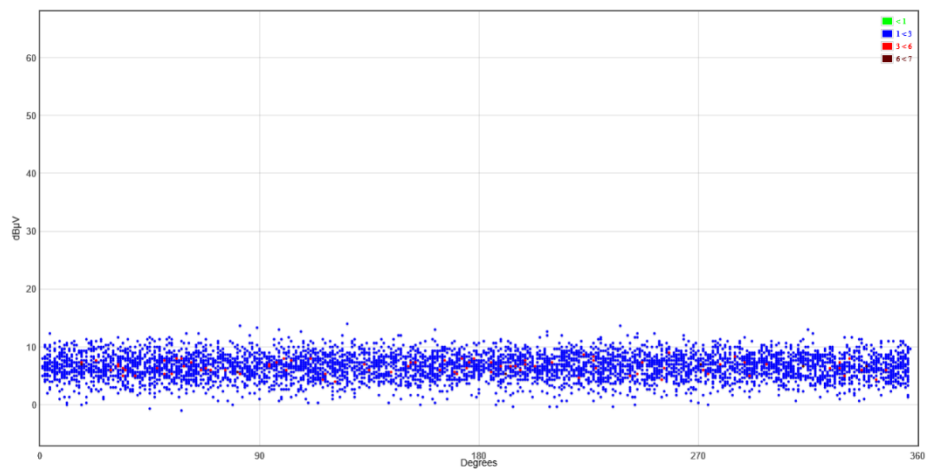
Figure 18 Ultrasonic phase resolved plot from Interruptible VT-UA PT compartment (front): Classification- Noise

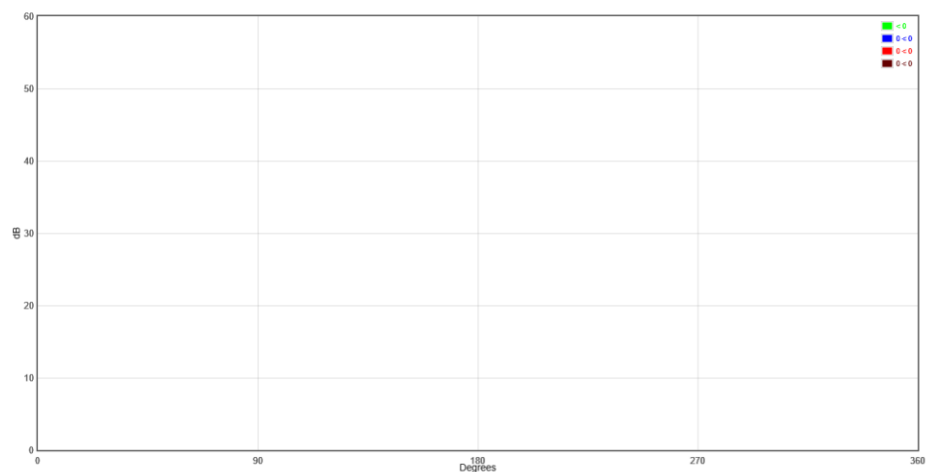
Figure 19 TEV phase resolved plot from Interruptible 52-UMB cable compartment (rear): No internal PD evident

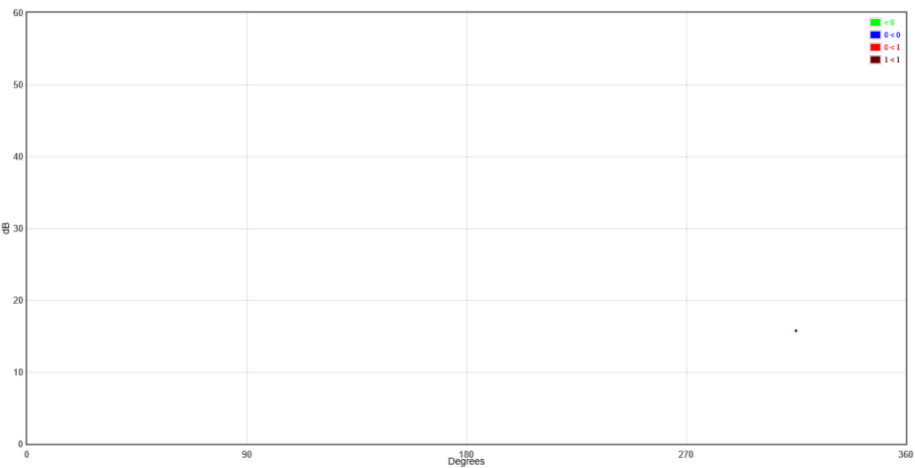
Figure 20 TEV phase resolved plot from Interruptible 52-UMB breaker compartment (front): No internal PD evident

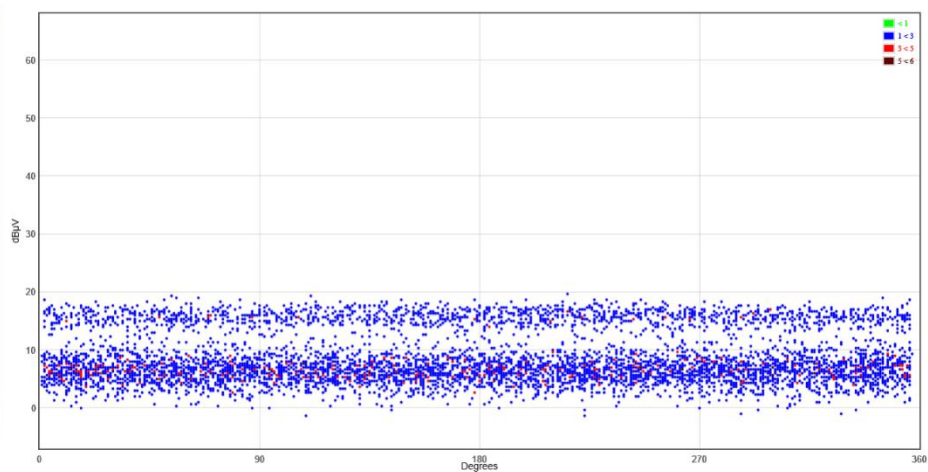
Figure 21 Ultrasonic phase resolved plot from Interruptible 52-UMB cable compartment (rear): Classification- Noise

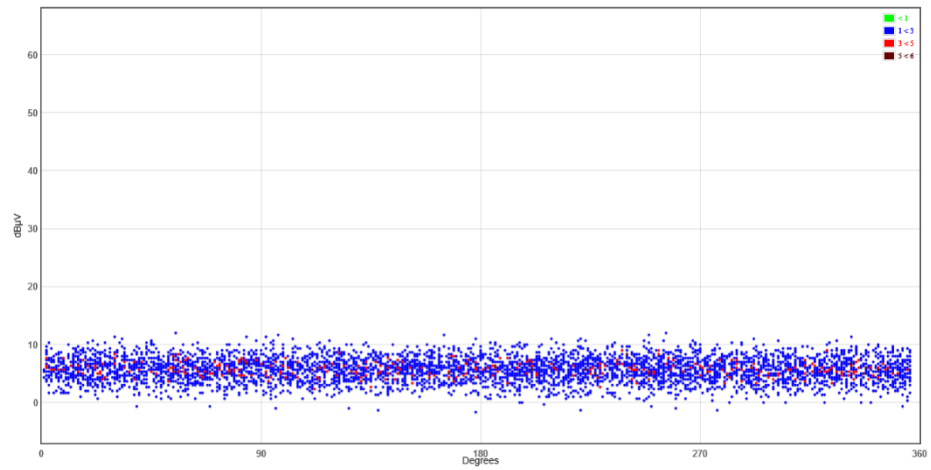
Figure 22 Ultrasonic phase resolved plot from Interruptible 52-UMB breaker compartment (front): Classification- Noise

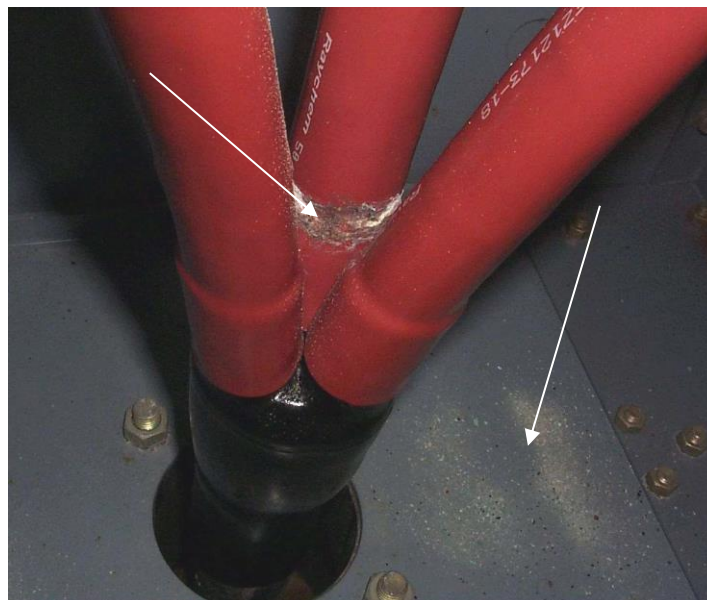
**Figure 1** Surface discharge activity between cable phases.

Note that white power in the base of the cable box or on horizontal surfaces is a good indication that discharge activity is present within switchgear.

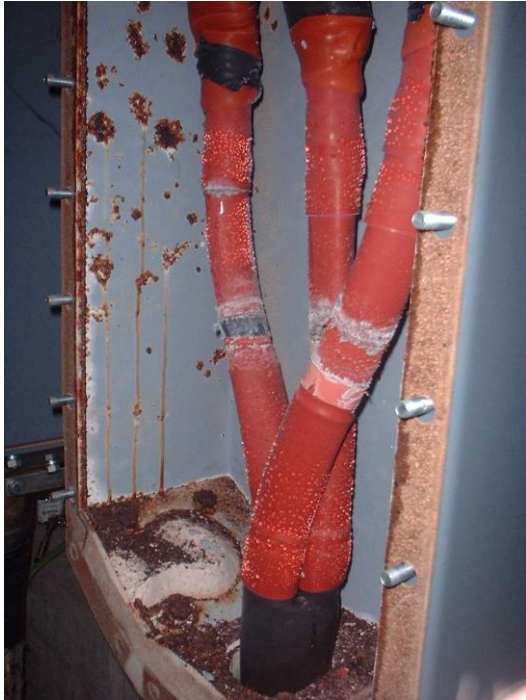
**Figure 2** Evidence of advanced discharge activity within an 11kV switchgear air insulated cable box.

Note the extensive rusting of steel box due to the formation of nitric acid within box as a result of partial discharge activity.

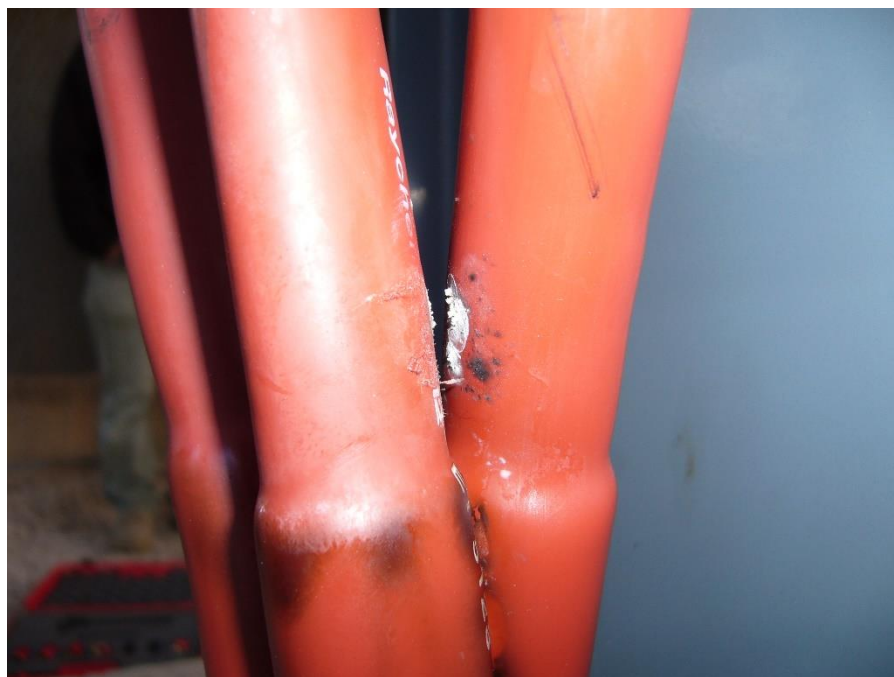
**Figure 3** Discharge activity between cable phases within an air insulated cable box.  
Note white powder deposit on polymeric surfaces.

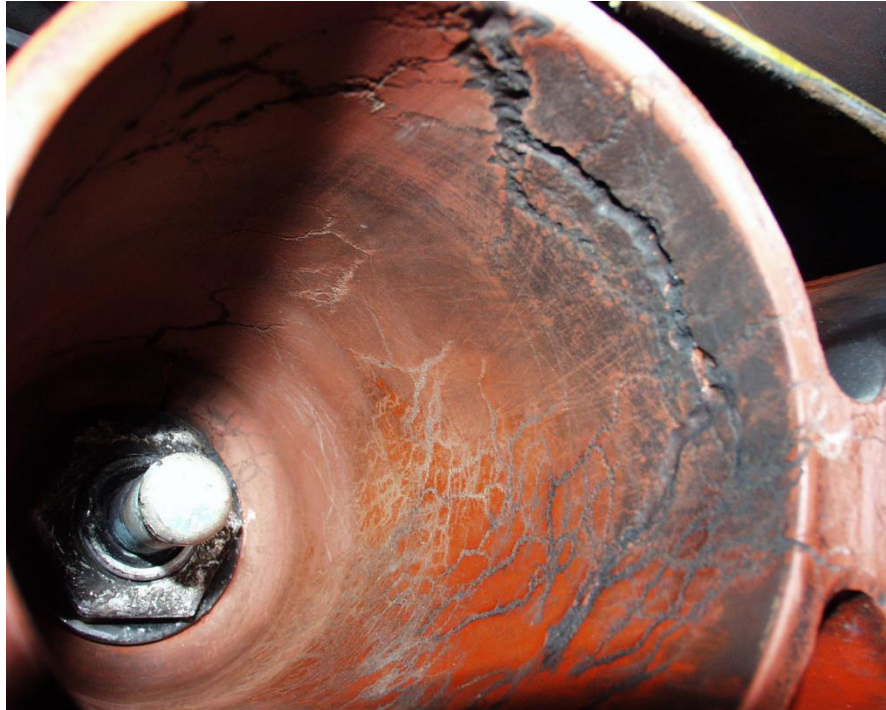
**Figure 4** Advanced surface discharge activity within the resin spout of an 11kV circuit breaker.

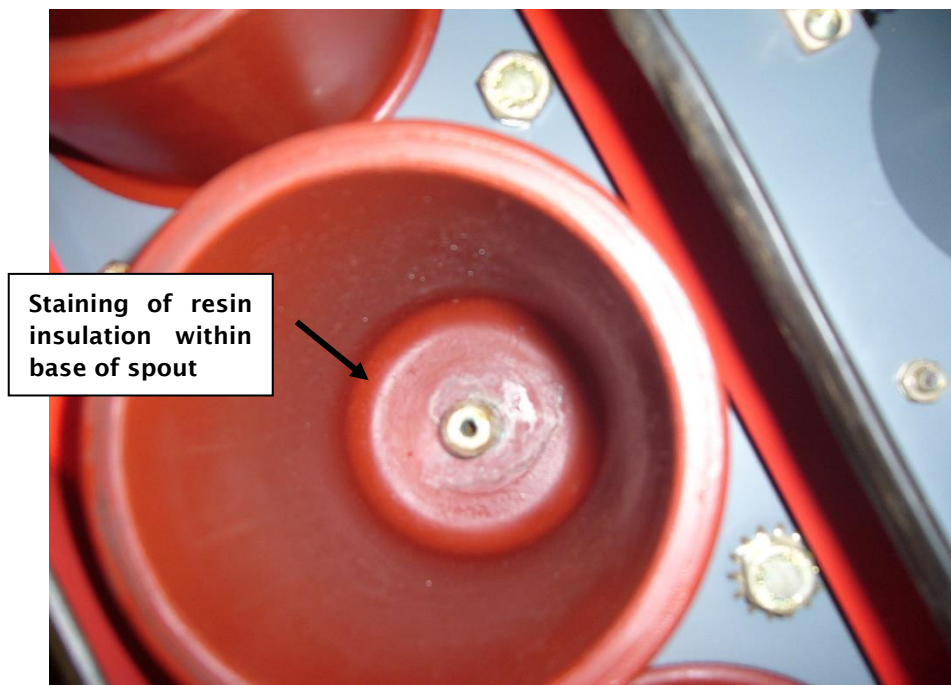
**Figure 5** Staining of resin insulation within 11kV circuit breaker spout caused by the effects partial discharge activity

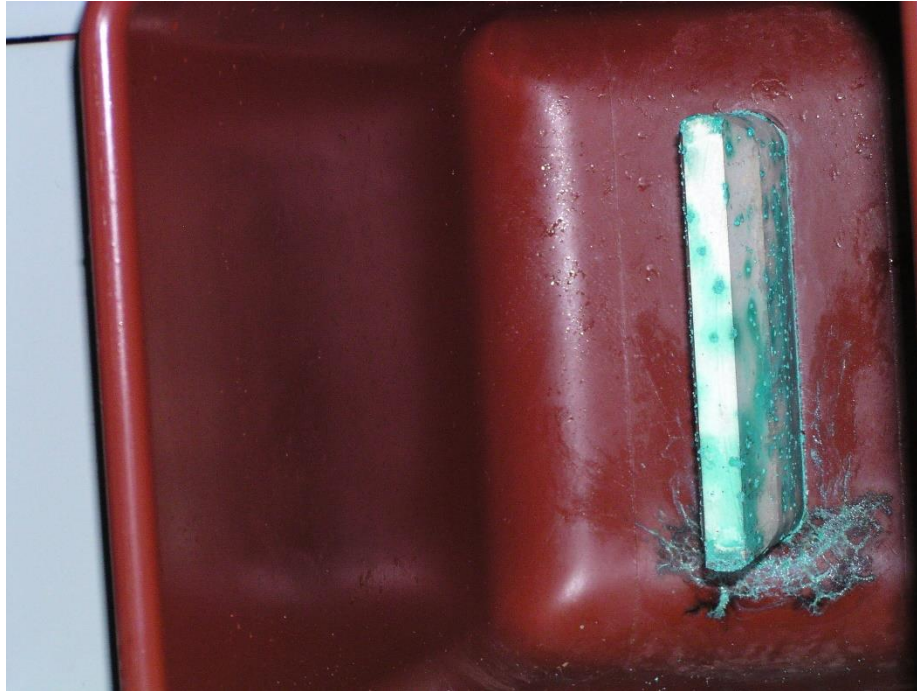
**Figure 6** Evidence of surface discharge activity within fixed portion resin spout of an 11kV circuit breaker.

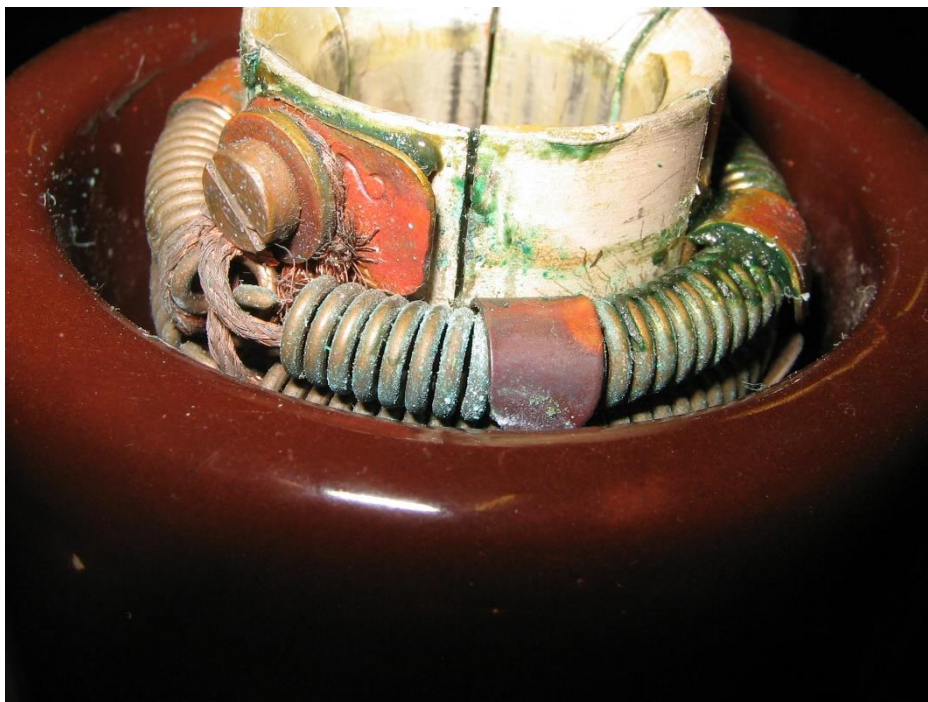
**Figure 7** Evidence of discharge activity within a porcelain contact cluster of an 11kV circuit breaker.

Note the green corrosion product on the surface of the contact cluster.
