**CIGRE Regional South-East European Conference - CMDM 2017 (3rd edition)  
October 10th - 12th 2016 , University "Politehnica" of Bucharest, Romania**

**Paper Number 117**

**Demonstration of an Online Continuous Monitoring System for  
Partial Discharge on Critical HV Cables**

**G K EARP\***  
**EA Technology Ltd.**  
**United Kingdom**

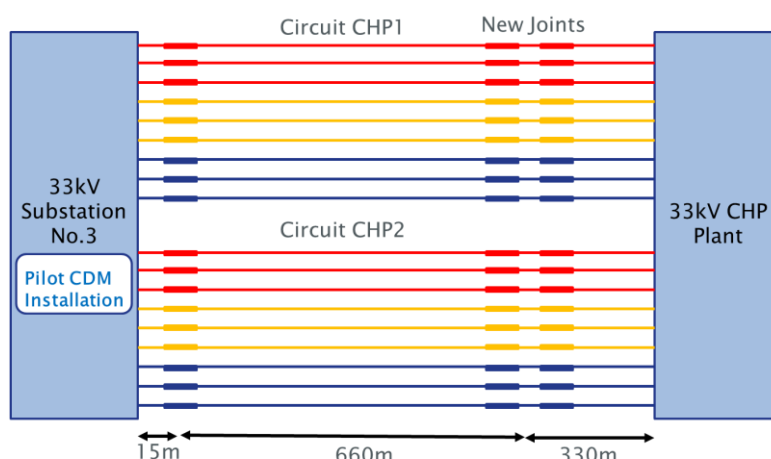
Figure 1 Substation/CHP Feeder Cable Arrangements Following Joint Replacement

During August/September 2016 an on-line CDM pilot system was installed within one of the main 33kV Electricity Distribution Substations at INEOS's Olefins and Polymers manufacturing site at Grangemouth in Scotland. The purpose of the monitor was to detect the presence of PD on 18 critical Feeder Cables between the substation and the CHP plant. The 18 feeder cables are arranged as two ganged circuits, with each phase having three separate cables in parallel to carry the full output current of circa 2,300A from the CHP plant. Each of these cables are approximately 1km long and of XLPE construction. As constructed each contained a pair of joints - one close to the substation end, and one approximately 330m from the CHP plant end. Because there had been a history of problems associated with the joints nearest the CHP plant end, INEOS took the decision to replace all 18 joints during a planned maintenance shut down in September 2016. Each removed joint was replaced with a pair of new joints and a short length of XLPE cable to bridge the gap (36 new joints in total). At the same time, the CDM was installed in the 33kV Substation No3 to monitor the cables' condition when power was restored following the maintenance outage. Figure 1 shows the arrangement following the joint replacement.

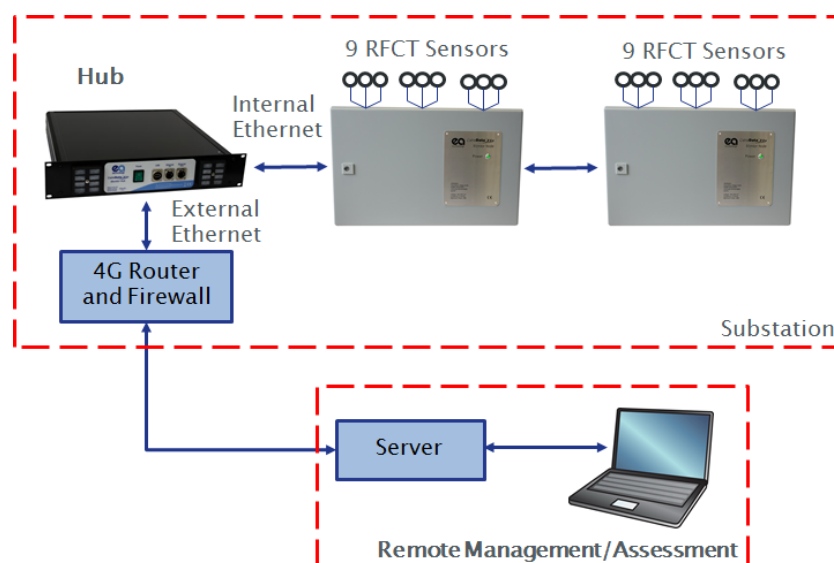
Figure 2 Block Diagram of the CDM Pilot System Installed in the 33kV Substation at INEOS

The CDM is a distributed cable PD monitoring system consisting of a central Hub and numerous distributed Nodes and sensors. The Nodes detect and measure PD activity and then send the information back to the Hub where it is processed and stored. Recorded data can be viewed from the Hub, or a computer connected on the same network, through a web interface. The data stored on the CDM Hub can also be accessed remotely via 4G over the mobile phone communications network using a standard web browser on a personal computer. Figure 2 shows a block diagram of the CDM system installed at INEOS for the pilot study.

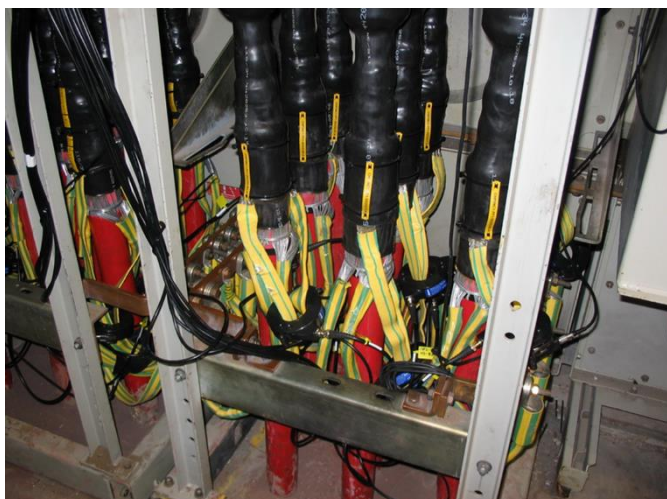
**Figure 3 RFCTs Clipped Around the CHP Cable Screen Earth Terminations**

The CDM is an on-line monitoring system which means that it monitors for PD under normal cable operating conditions with system volts applied and, unlike some traditional methods, it does not require an outage for detecting PD. Detection is achieved by clipping Radio Frequency Current Transformer (RFCT) sensors around the cable earth screens at the cable terminations within the substation. The RFCTs can detect the minute high-frequency current pulses that are created when PD occurs inside cables [1]. Figure 3 shows the RFCTs clipped around the CHP cable earth screens. Figure 4 shows the CDM measurement Nodes mounted on the wall in the 33kV Substation. The Hub computer was mounted within an existing 19" SCADA rack in the substation. The system has been monitoring the PD activity on the CHP feeder cables since the beginning of October 2016 when the CHP plant was bought back on line following the maintenance shut down.

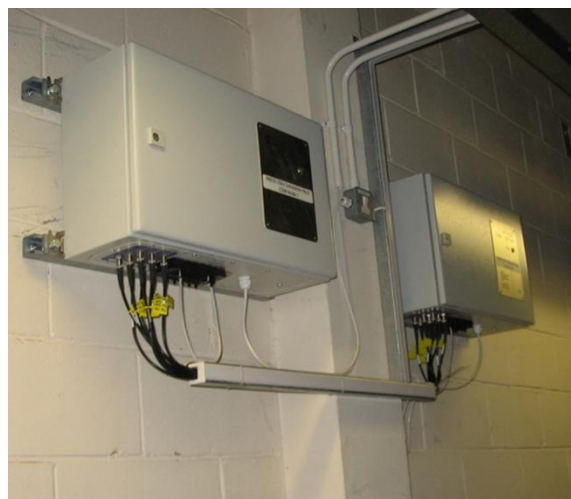
**Figure 4 CDM Measurement Nodes Mounted Within Substation**

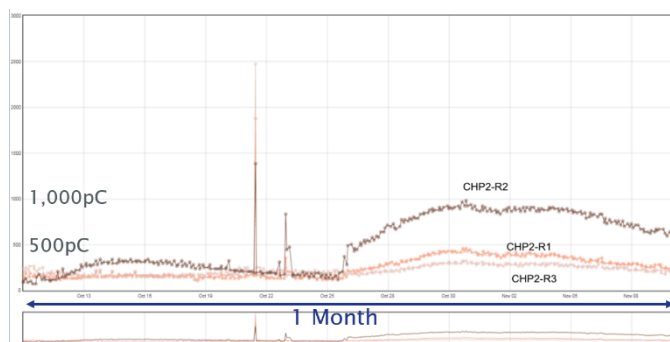
**Figure 9 Event Amplitude Mean (pC) for Cable CHP2-R2 for a Period of 1 Month After the PD Started**

There was no significant similar increase observed on any of the other cables although later, when the Event Amplitude Mean level reached higher magnitudes, there was evidence of matching (but lower level) activity at the same time on the other two cables in parallel with CHP2-R2, i.e. CHP2-R1 and CHP2-R3 on the same phase. This is shown in Figure 9. This is attributed to pickup from CHP2-R2, because the three cables are connected in parallel at both ends. This provides preferential earth paths at the terminations for the reflected PD pulse currents. It is also highly unlikely that three separate PD sources would start in all three cables at the same time, and mirror the activity levels. It can be seen that within a month the Event Amplitude Mean activity level for CHP2-R2 had risen from 300pC to around 1,000pC, although it is interesting to note the undulations in the measured levels as opposed to a steady increase.

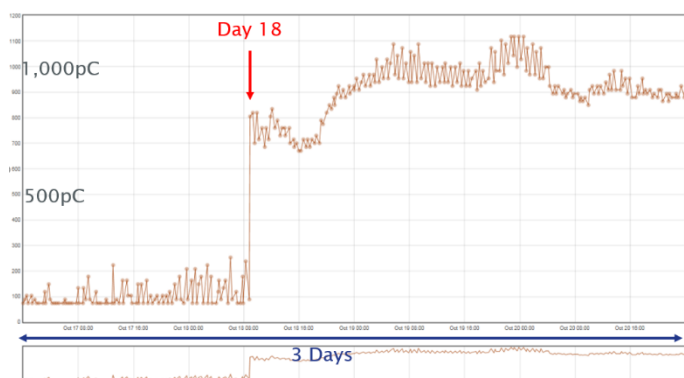
**Figure 11 Event Amplitude Mean (pC) for Cable CHP2-B3 for a Period of 3 Days Commencing 17 Days After Energisation**

The Event Amplitude Mean plot of Figure 11 shows that PD started on cable CHP2-B3 18 days after energisation. This was the second cable identified to have PD by the VLF test. Unlike CHP2-R2, the start was much more abrupt and within one day it had exceeded 1,000pC. There was matching (but lower level) activity attributed to pick up that commenced at the same time on the other two cables in parallel with CHP2-B3, i.e. CHP2-B1 and CHP2-B2, which is not shown. A 2-minute phase plot in Figure 12, taken 3 days after the PD started, shows classic PD activity with some events as large as 3,000pC.

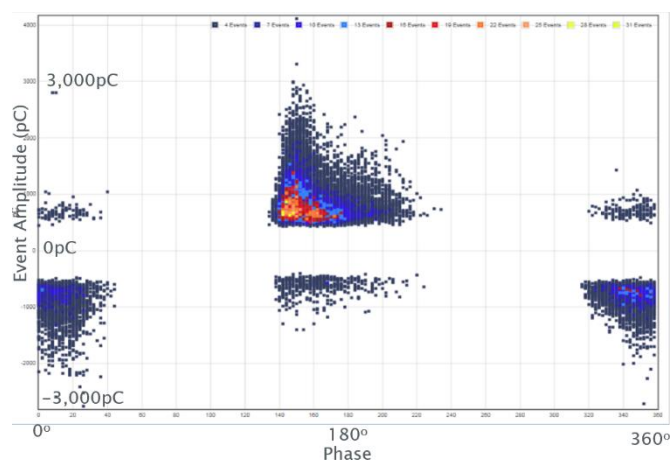
**Figure 12 2-minute Phase Plot for CHP2-B3 Captured 20 Days After Energisation**
